Visual defects of painted surfaces on ABS/PC injected parts

Abstract— A high surface quality is necessary for automotive industry especially for exterior parts. Most outdoors polymers are painted for aesthetic reasons as metallic parts. The quality aspect must be indistinctive of the nature of the substrate, metal or polymer, to produce a global high quality aspect of the vehicle. Whatever the material, metal or polymer, sometimes defects appear in small locations which lead to the rejection of the automotive part. Here is presented a specific defect, aligned dots on the painted polymer part which are not present before painting process. The analytical method is almost universal but the defect is specific. It results from the conjugation of polymer nature and process and from the nature of painting.

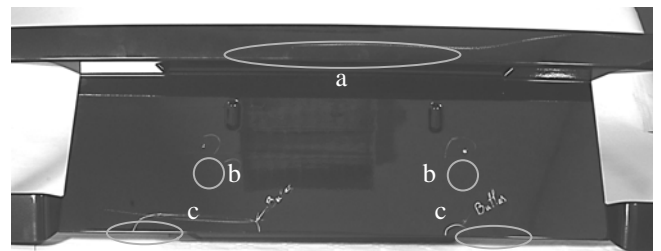
Figure 1. A cap of registration plate (five defective zones are bordered)

More than 99% of the painted surface is glossy with a homogeneous color. The defects appear only very small zones located always at the same location for each geometry (fig. 1, 2): near the mold-gate (fig. 1a), at the contact of weld-lines (fig. 1b) and at the end of filling zone (parting-line) (fig. 1c, 2). The weld-line results from a bypass of an obstacle in the mould by the molten polymer. All these locations are tightly connected to process geometry. They appear on flat surface with a complex flow (fig. 1b) and on regions with a very small radius curvature (fig. 1a, 1c, 2). For optical reasons they are more visible on a flat surface than on a small radius.

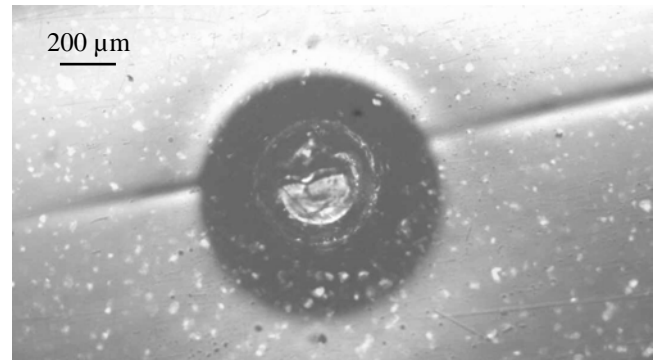
Figure 4 : A bubble (dot) observed by optical microscopy on a line defect

The bubble is centered on the parting-line and its size varies from 50 μm , for the smallest, up to 400 μm . Their size is sufficiently large to be observed, 60-70 μm is the norm for a detection of an isolated detail (1" arc) with naked eye. Hypothetic individual bubbles with a size smaller than 10 μm could be undetected following the industrial test of quality. The size of the defect and their correlation (alignment) are crucial for their detection. The dark ring around a bright circle including some details results from a protuberance of the surface which produces this optical effect (dark-field reflection) (fig. 4). The blue pigments inside the basecoat can be also observed as clear dots on figure 4. The bubbles can be observed in more detail with SEM (FEI/Philips XL30ESEM) (fig. 5).

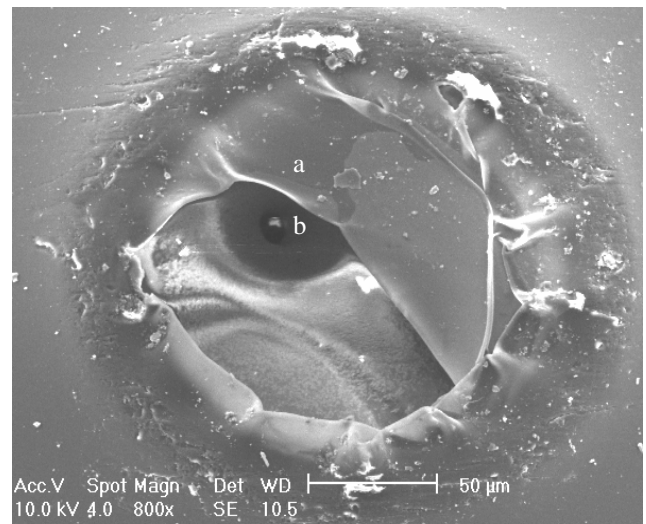
Figure 5: SEM observation of a bubble with a broken foil a) and a hole b)

A small bubble (diameter $\sim 200\mu\text{m}$) is presented in figure 5 which is significant of all the bubbles observed on the

painted parts. They are formed by a cavity partly covered by a very thin foil which mainly produces the protuberance observed by optical microscopy. The foil is not complete and has been broken (fig. 5a). A hole is shown out in the bottom of the bubble (fig. 5b). From these observations it is suspected that the bubble is located in the paint layers with no clear evidence of its presence in a specific layer.

The strong correlation between these different experimental facts strongly suggests an explanation. A simple one is to suppose a crack is provoked by some painting solvents which initiate the crack in the polymer. In combination with this primary effect, the solvent diffuses inside the crack. At the end of the industrial process the painted part is heated. The solvent contained inside the crack is vaporized and strongly expands. Gas escape from the crack at the weak points of the primer and basecoat to form holes (fig. 5b). Then the gas inflates the bubble in the topcoat up to the rupture of the thin foil (fig. 5a).

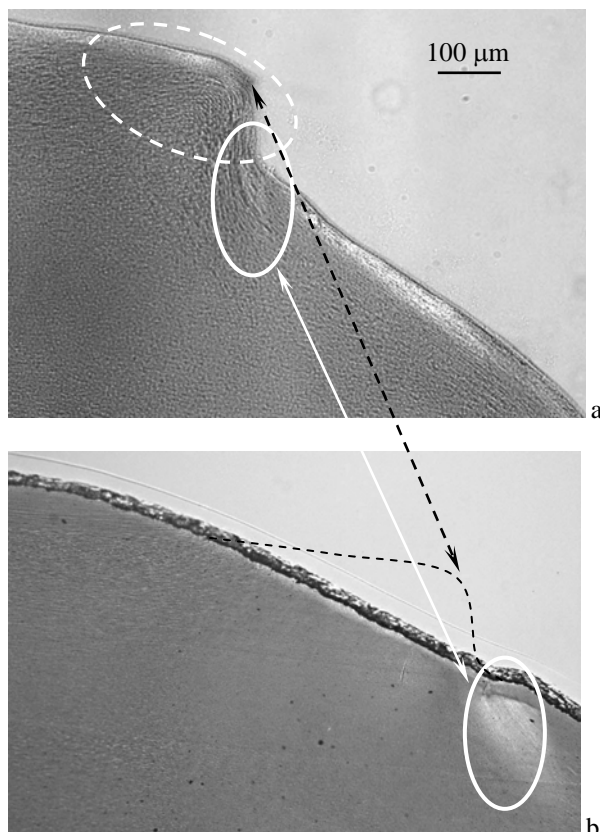
Figure 8: optical microscopy observation under polarization with a lambda plate of thin cuts ($e = 5 \mu\text{m}$) from injected parts before (a) and after polishing (b)

Observation under light polarization shows-out the molecular orientation parallel to the surface (fig. 8a) which is partly erased by polishing action. The orientation is complex in this initial protuberance [4]. It leads to a molecular orientation almost perpendicular to the surface after polishing and an initial crack can be detected in this particular zone (fig. 8b). The diffusion of solvents inside the polymer part is easier as an effect of this initial crack and of molecular orientation which favors the solvent diffusion. The solvent only widens the crack. This effect of a complex orientation on polymer cracks formation is observed on this zone without polishing and on weld-line where a complex orientation is also present. The cracks result from a local molecular orientation in conjunction with contact with solvents. The heating bursts the solvent and highly deforms the topcoat to form the bubbles. This is the critical step for the formation of the visual defect.
