## Visual defects of painted surfaces on ABS/PC injected parts

Eponine Raynaud, Evelyne Darque-Ceretti, Bernard Monasse, Philippe Duquesne, Frédéric Georgi. Visual defects of painted surfaces on ABS/PC injected parts. MATERIALS & SENSATIONS 2008, Oct 2008, Pau, France. hal-01444604

# Visual defects of painted surfaces on ABS/PC injected parts

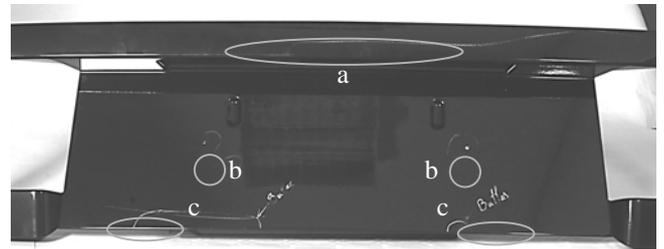
Figure 1. A cap of registration plate (five defective zones are bordered)

More than 99% of the painted surface is glossy with a homogeneous color. The defects appear only very small zones located always at the same location for each geometry (fig. 1, 2): near the mold-gate (fig. 1a), at the contact of weld-lines (fig.1b) and at the end of filling zone (parting-line) (fig. 1c, 2). The weld-line results from a bypass of an obstacle in the mould by the molten polymer. All these locations are tightly connected to process geometry. They appear on flat surface with a complex flow (fig. 1b) and on regions with a very small radius curvature (fig. 1a, 1c, 2). For optical reasons they are more visible on a flat surface than on a small radius.

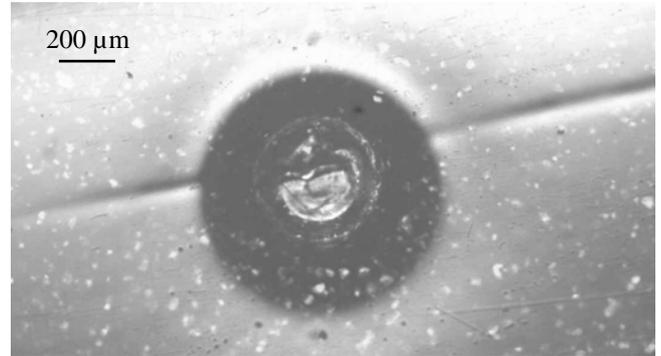
Figure 4 : A bubble (dot) observed by optical microscopy on a line defect

The bubble is centered on the parting-line and its size varies from 50 μm, for the smallest, up to 400 μm. Their size is sufficiently large to be observed, 60-70 μm is the norm for a detection of an isolated detail (1'' arc) with naked eye. Hypothetic individual bubbles with a size smaller than 10 μm could be undetected following the industrial test of quality. The size of the defect and their correlation (alignment) are crucial for their detection. The dark ring around a bright circle including some details results from a protuberance of the surface which produces this optical effect (dark-field reflection) (fig. 4). The blue pigments inside the basecoat can be also observed as clear dots on figure 4. The bubbles can be observed in more detail with SEM (FEI/Philips XL30ESEM) (fig. 5).

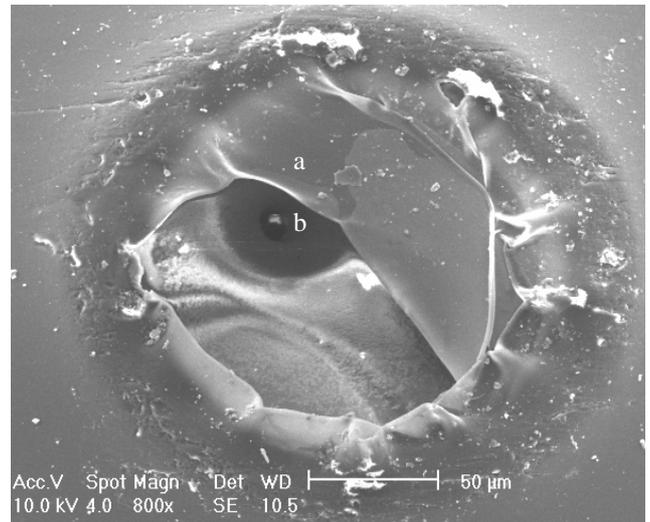
Figure 5: SEM observation of a bubble with a broken foil a) and a hole b)

A small bubble (diameter ~200μm) is presented in figure 5 which is significant of all the bubbles observed on the

Painted parts. They are formed by a cavity partly covered by a very thin foil which mainly produces the protuberance observed by optical microscopy. The foil is not complete and has been broken (fig. 5a). A hole is shown out in the bottom of the bubble (fig. 5b). From these observations it is suspected that the bubble is located in the paint layers with no clear evidence of its presence in a specific layer.

The strong correlation between these different experimental facts strongly suggests an explanation. A simple one is to suppose a crack is provoked by some painting solvents which initiate the crack in the polymer. In combination with this primary effect, the solvent diffuses inside the crack. At the end of the industrial process the painted part is heated. The solvent contained inside the crack is vaporized and strongly expands. Gas escape from the crack at the weak points of the primer and basecoat to form holes (fig. 5b). Then the gas inflates the bubble in the topcoat up to the rupture of the thin foil (fig. 5a).

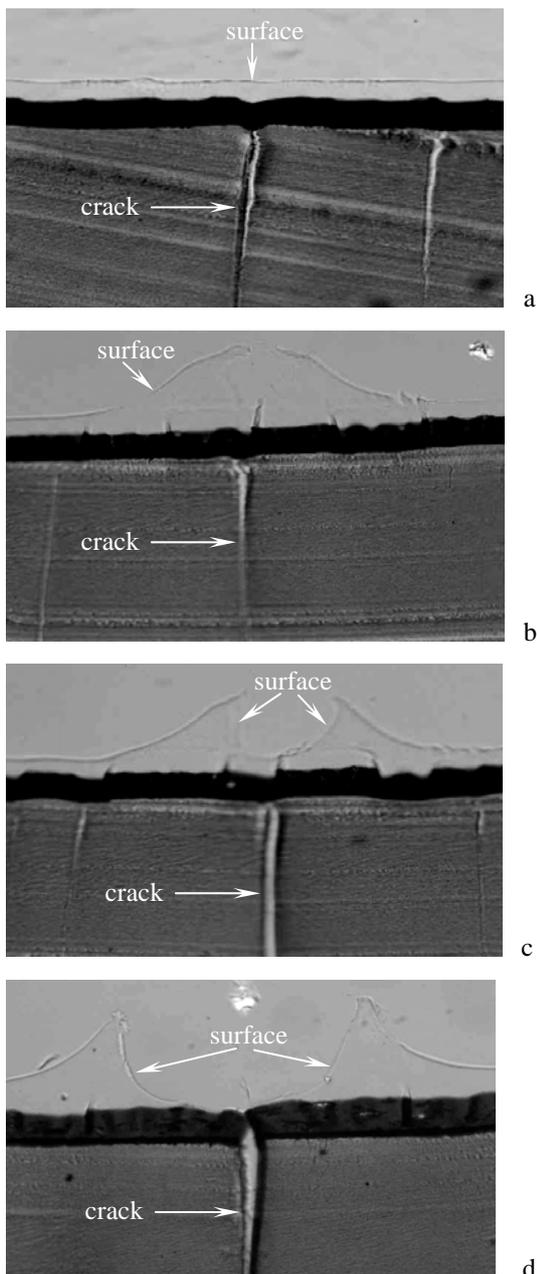
Figure 6: optical microscopy under transmission of thin cuts through half a bubble: from a border (a) to the diameter (d)

The bubble is confined in the topcoat and results from deformation of the material only in this superficial layer. These bubbles and volcanoes have very similar shapes. An observation of superficial part of ABS-PC shows the presence of a crack perpendicular to the polymer surface. This crack is stopped at the boundary with the primer layer (fig. 6a to 6c) aside in the centre of the bubble where the primer and the basecoat are broken (fig. 6d). This rupture is observed as a hole in the bottom of the bubble (fig. 5b). In that point, there is a direct connection between the crack inside the polymer and the bubble.

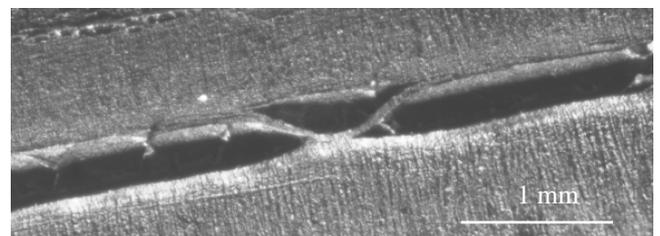
Figure 7: Macrograph of a crack on the surface after immersion inside solvents

The crack appears on the surface along the line defined in figures 3 and 4. The present crack and observed on

Painted polymer have almost the same depth. The result of this experiment confirms the role of solvents to open polymer crack and to form a reservoir for the solvent.

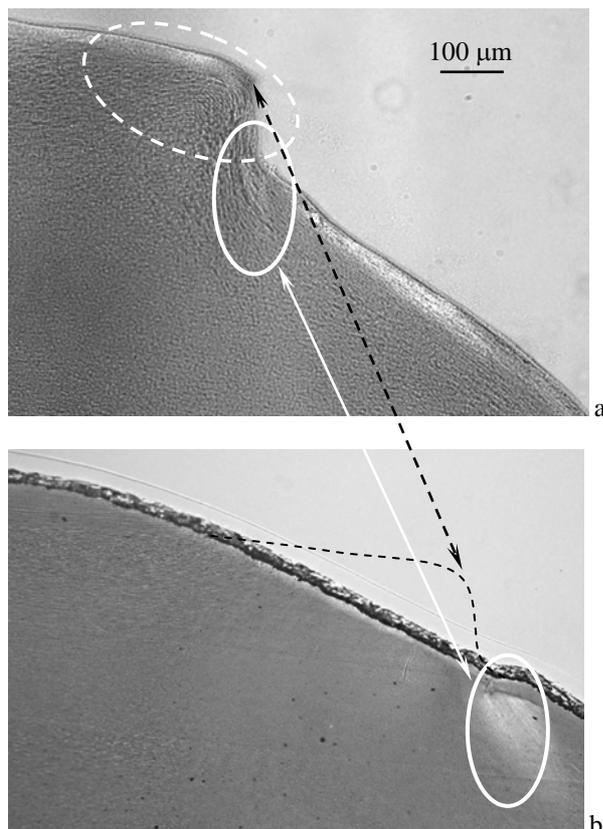
Figure 8: optical microscopy observation under polarization with a lambda plate of thin cuts ( $e = 5 \mu\text{m}$ ) from injected parts before (a) and after polishing (b)

Observation under light polarization shows-out the molecular orientation parallel to the surface (fig. 8a) which is partly erased by polishing action. The orientation is complex in this initial protuberance [4]. It leads to a molecular orientation almost perpendicular to the surface after polishing and an initial crack can be detected in this particular zone (fig. 8b). The diffusion of solvents inside the polymer part is easier as an effect of this initial crack and of molecular orientation which favors the solvent diffusion. The solvent only widens the crack. This effect of a complex orientation on polymer cracks formation is observed on this zone without polishing and on weld-line where a complex orientation is also present. The cracks result from a local molecular orientation in conjunction with contact with solvents. The heating bursts the solvent and highly deforms the topcoat to form the bubbles. This is the critical step for the formation of the visual defect.
