**Comparison of the accumulation of fibre breaks
occurring in a unidirectional carbon/epoxy composite
identified in a multi-scale micro-mechanical model with
that of experimental observations using high resolution
computed tomography**

Comparison of the accumulation of fibre breaks occurring in a unidirectional carbon/epoxy composite identified in a multi-scale micro-mechanical model with that of experimental observations using high resolution computed tomography

ABSTRACT

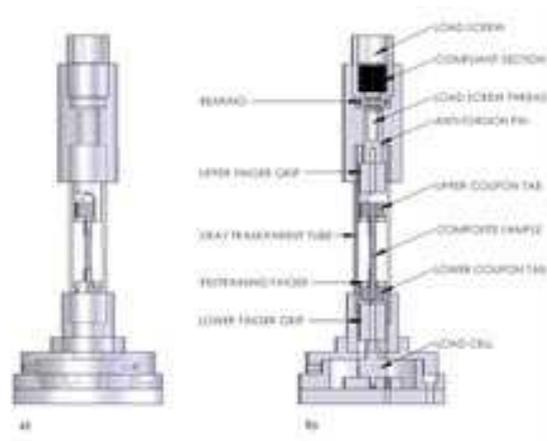
FIG. 2 – Screw driven loading device.

A screw driven load frame, Figure 2 was used to load the samples in situ to failure. The samples were taken to incremental loads up to final failure. At each load step the samples were imaged at ID19 beamline at the European Synchrotron Radiation Facilities (ESRF) in Grenoble.

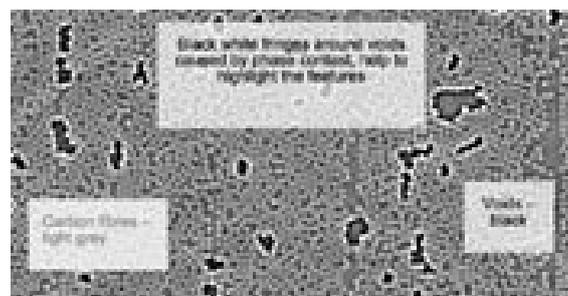
FIG. 3 – Example of absorption and phase contrast imaging.

ID19 beamline routinely achieves resolutions of $300nm$ and with specialised optics can achieve even high resolutions. The optics used in this studied enabled a voxel resolution of $1.4\mu m$ to be achieved. The coherent beam available from the synchrotron makes it possible for phase contrast imaging to be used, so an edge detection method can be exploited. This enables a crack opening of $1/10$ th of the voxel size to be distinguishable and assists in finding small features such as fibre breaks.

High resolution is achieved via the high beam flux falling on a very high resolution detector system. In this experiment a FReLoN (Fast Read-out, Low Noise) detector attached to a 2048×2048 pixel CCD camera was used. In comparison to conventional micro focus CT this enables relatively short exposure times (approximately 5 minutes a scan), so scans take a matter of minutes rather than hours. The detector measures the intensity distribution of the X-ray beam transmitted through the sample, which is proportional to the material density and also carries an energy dependence that is a function of the material composition [9]. The X-ray absorption is represented by corresponding grey scales and thus material and features such as cracks, voids and fibre breaks can be distinguished via a characteristic grey scale level shown in Figure 3. The result of the phase contrast imaging can also be seen in Figure 3, as black and white fringes surrounding the voids. Further details of the imaging setup can be found at [8].

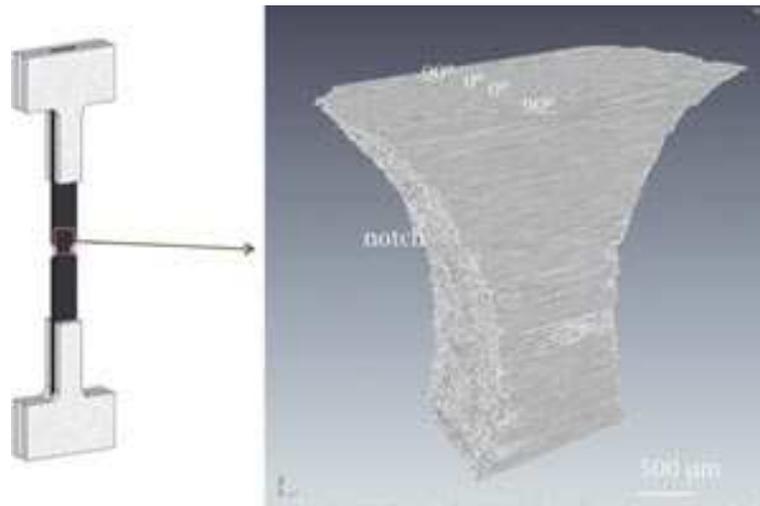
FIG. 4 – 3D reconstruction of notched sample.

Figure 4 shows the location in which the sample has been analysed and identifies the ply layup on a 3D reconstructed volume. The in-situ loading enables the damage progression to be identified up to failure, where Figure 5 shows the crack propagation in the same sample taken up to failure at 10% increments of the ultimate tensile strength, UTS. The transverse ply cracks occur early on in loading at 30% of the UTS. Further loading induces 0° splits which are then followed by delaminations.

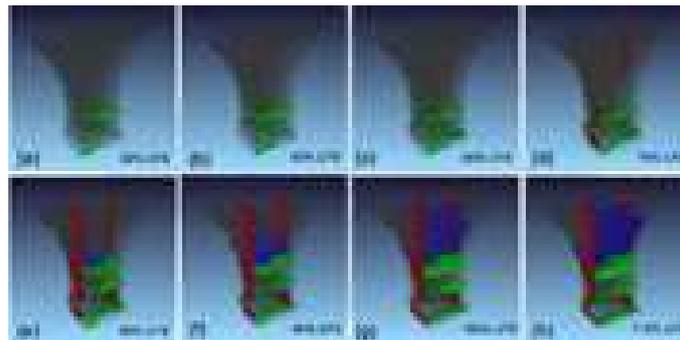
FIG. 5 – In-situ loading of sample. Composite made partially transparent. Transverse ply cracks in green, 0° splits in red and delamination in blue.

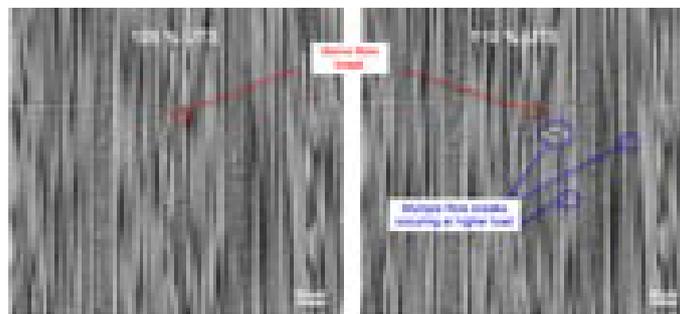
FIG. 6 – Fibre break accumulation in the same sample at different load increments.

The 3D capabilities of the CT imaging enables all fibre breaks to be identified in the sample through out the whole imaged volume. Figure 6 shows fibre breaks in exactly the same sample at two load increments. The same locations can be found in both samples using the marker particles. It is possible to see the accumulation of fibre breaks occurring with increasing load. Figure 7 shows a graph of the accumulation fibre breaks occurring in the samples with increasing load. The results show a distinct acceleration of fibre breaks occurring in the last 90% of loading.

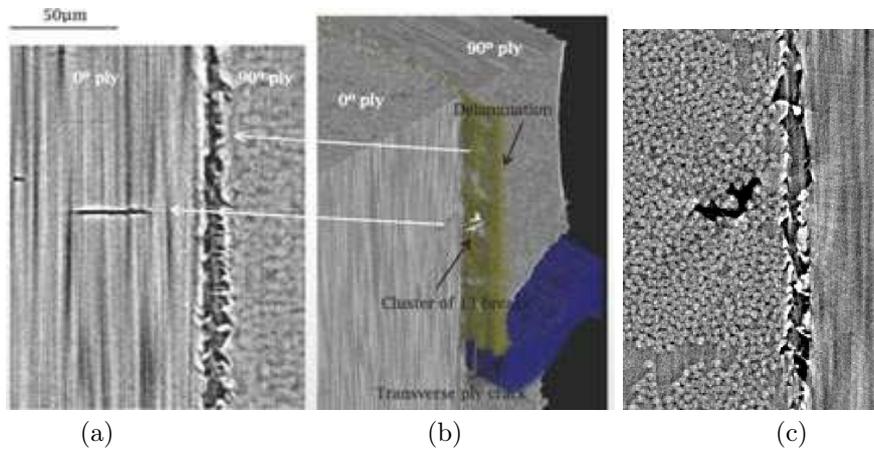
FIG. 8 – Fibre break identification, a) view of cluster aligned with fibres, b) 3D view, part of composite made transparent to reveal cluster, c) view of cluster face onto fibres.

It has also been possible to capture the growth of fibre clusters. Table 1 shows the cluster formation with increasing load. At 94% of the failure load 3 large clusters were found, consisting of 6, 8 and 12 neighbouring fibres. The largest of which can be seen in Figure 8. Where it is possible to view the clusters at all orientations and in 3 dimensions.
