**Comparison of the accumulation of fibre breaks  
occurring in a unidirectional carbon/epoxy composite  
identified in a multi-scale micro-mechanical model with  
that of experimental observations using high resolution  
computed tomography**

A.E. Scott, I. Sinclair, S.M. Spearing, M. Mavrogordato, Anthony R. Bunsell,  
Alain Thionnet

A.E. Scott, I. Sinclair, S.M. Spearing, M. Mavrogordato, Anthony R. Bunsell, et al.. Comparison of the accumulation of fibre breaks occurring in a unidirectional carbon/epoxy composite identified in a multi-scale micro-mechanical model with that of experimental observations using high resolution computed tomography. *Matériaux* 2010, Oct 2010, Nantes, France. 9 p. hal-00572425

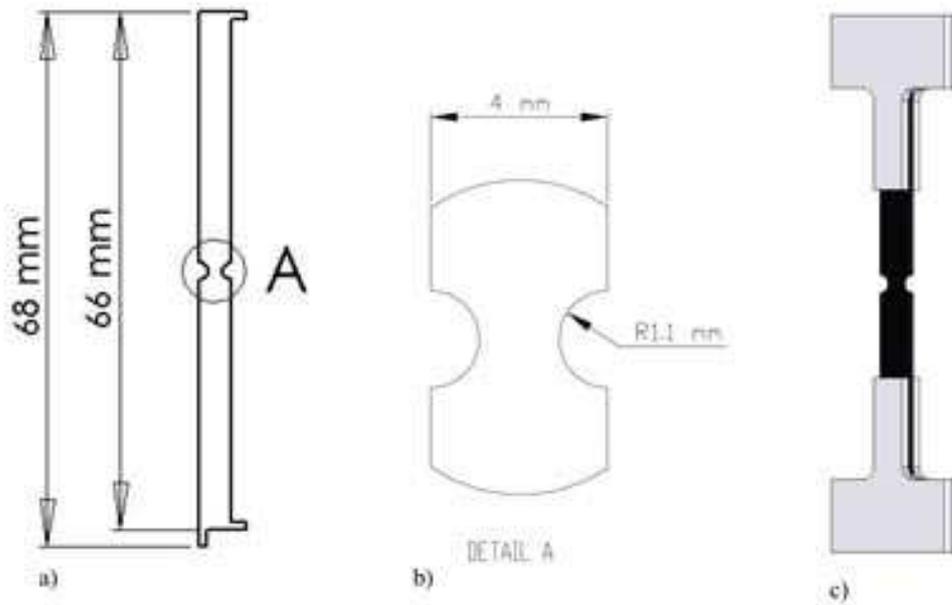
FIG. 1 – Notched sample specimen, a) and b) dimensions of the sample, c) illustration of end tabs used to grip during load.

Laminated  $[0^\circ/90^\circ]_s$  T700 aerospace grade carbon fibre pre-preg specimens were provided by Airbus and prepared by Wright *et al.* [8] for tensile loading. The double edge notches were machined using an abrasive waterjet to the geometry shown in Figure 1. The notched samples were used to ensure all damage mechanisms close to final failure could be captured. A sparse population of small aluminium particles ( $\approx 4\mu m$ ) were embedded into the laminates for fiducial markers.

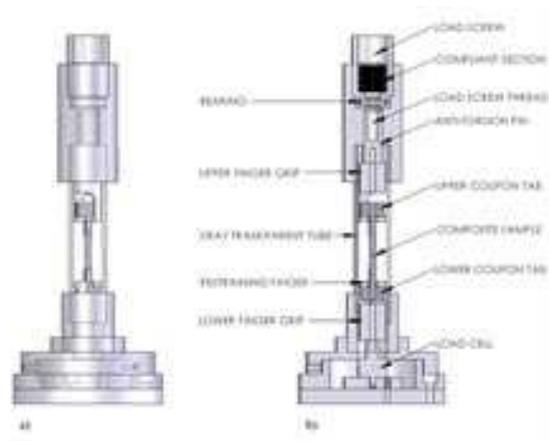
FIG. 2 – Screw driven loading device.

A screw driven load frame, Figure 2 was used to load the samples in situ to failure. The samples were taken to incremental loads up to final failure. At each load step the samples were imaged at ID19 beamline at the European Synchrotron Radiation Facilities (ESRF) in Grenoble.

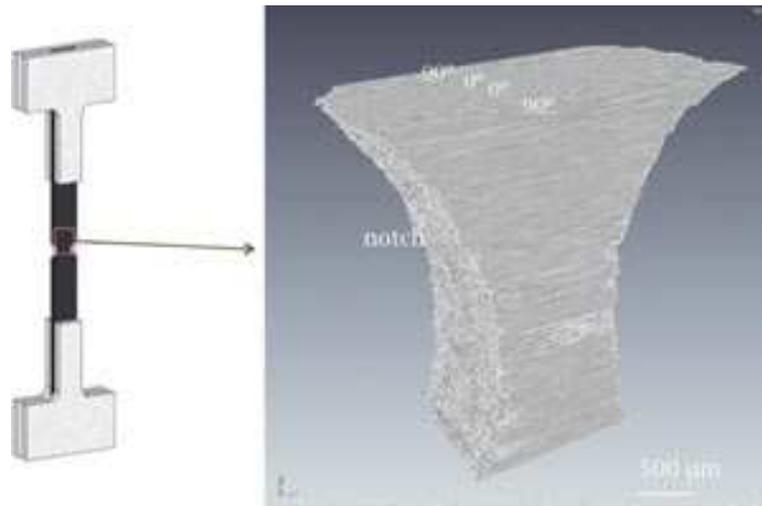
FIG. 4 – 3D reconstruction of notched sample.

Figure 4 shows the location in which the sample has been analysed and identifies the ply layup on a 3D reconstructed volume. The in-situ loading enables the damage progression to be identified up to failure, where Figure 5 shows the crack propagation in the same sample taken up to failure at 10% increments of the ultimate tensile strength, UTS. The transverse ply cracks occur early on in loading at 30% of the UTS. Further loading induces  $0^\circ$  splits which are then followed by delaminations.

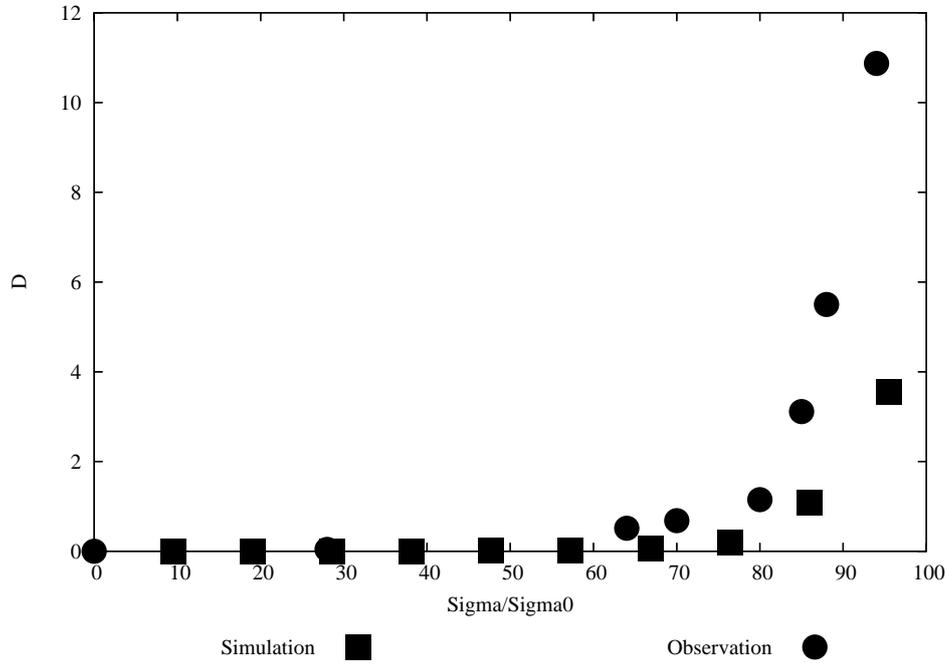
FIG. 7 – Density of fibre breaks ( $D$ ,  $nb/mm^3$ ) versus the increasing load ( $\text{Sigma}/\text{Sigma}_0$ ,  $\text{Sigma}_0 = \text{UTS}$ ). Comparison between observation and simulation.

The 3D capabilities of the CT imaging enables all fibre breaks to be identified in the sample through out the whole imaged volume. Figure 6 shows fibre breaks in exactly the same sample at two load increments. The same locations can be found in both samples using the marker particles. It is possible to see the accumulation of fibre breaks occurring with increasing load. Figure 7 shows a graph of the accumulation fibre breaks occurring in the samples with increasing load. The results show a distinct acceleration of fibre breaks occurring in the last 90% of loading.

The simulations have been carried out by the Finite Element Method (Figure 9) employing the Zebulon code developed at the Mines Paristech using a simplified  $FE^2$  multiscale process [37]. There is good correlation between the observations and simulations. In addition, the simulations show that close to the final fracture of the sample, the fibre breaks no longer appear at random but group to form clusters which indicate the beginning of (unstable) rupture of the sample [37].

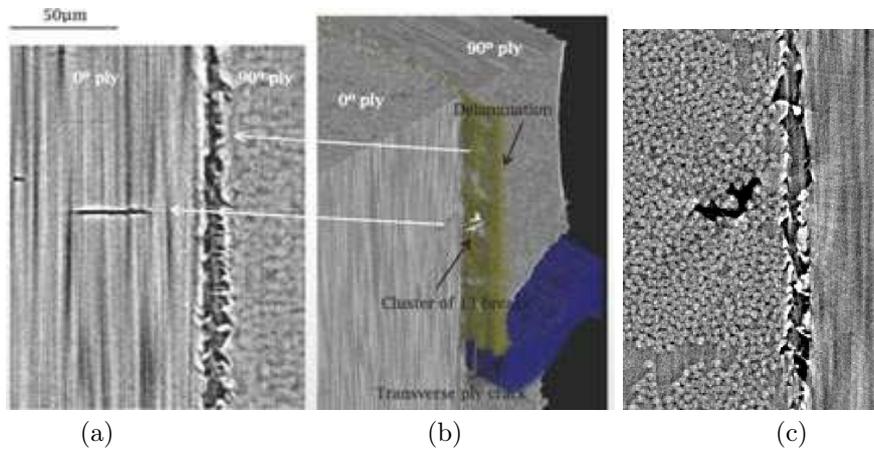
FIG. 8 – Fibre break identification, a) view of cluster aligned with fibres, b) 3D view, part of composite made transparent to reveal cluster, c) view of cluster face onto fibres.

It has also been possible to capture the growth of fibre clusters. Table 1 shows the cluster formation with increasing load. At 94% of the failure load 3 large clusters were found, consisting of 6, 8 and 12 neighbouring fibres. The largest of which can be seen in Figure 8. Where it is possible to view the clusters at all orientations and in 3 dimensions.

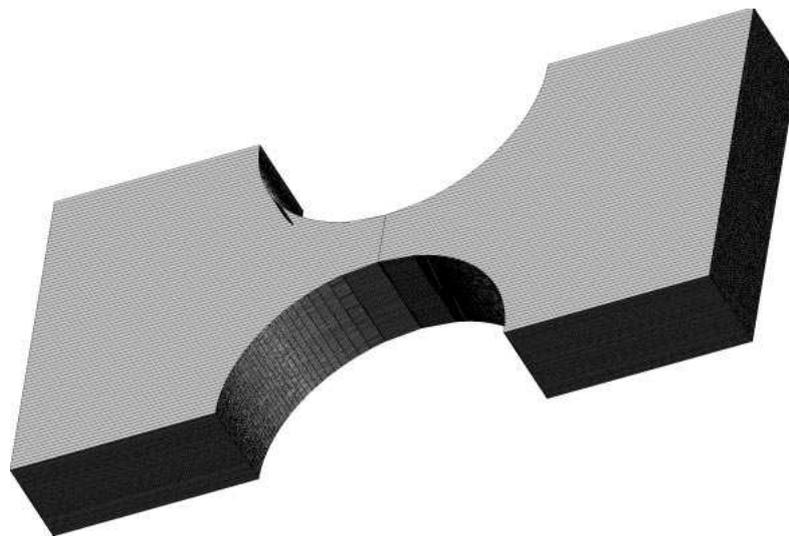
FIG. 9 – Mesh of the notched specimen.
