## High temperature creep properties and microstructural examinations of P92 welds

Charlotte Kalck, Benjamin Fournier, Françoise Barcelo, Laurent Forest,  
France Dalle, Pierre-François Giroux, Ivan Tournié, Anne-Françoise  
Gourgues-Lorenzon

Charlotte Kalck, Benjamin Fournier, Françoise Barcelo, Laurent Forest, France Dalle, et al.. High temperature creep properties and microstructural examinations of P92 welds. 9th Liege conference : materials for advanced power engineering, Sep 2010, Liege, Belgium. pp.424-434. hal-00592240

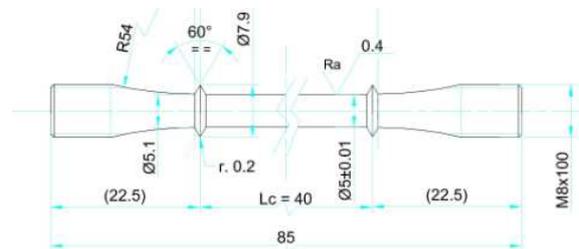
Figure 1: Scheme of creep specimen geometry.

Smooth cross-weld specimens were extracted from the weldment, along the longitudinal axis of the pipe. Their geometry is presented in figure 1.

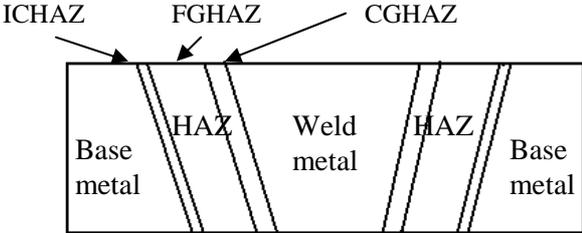
Figure 2: Scheme of the welded joint.

The various zones in the welded joint are schematically represented in Figure 2.

The welded joint is composed of a range of different microstructures which constitute the base metal, the welded joint and the heat affected zone (HAZ). The microstructure is related to the thermal history experienced during the welding.

The microstructure of HAZ varies along the distance from the fusion line.

The area close to the weld metal shows coarse parent austenite grains and is called the coarse-grained zone (CGHAZ). Then, next to the CGHAZ, the HAZ presents an area with very fine parent austenite grains (FGHAZ). A last zone, located between the base metal and the FGHAZ, presents a particular microstructure, made of martensite laths and prior austenite grains denoted the intercritical zone (ICHAZ).

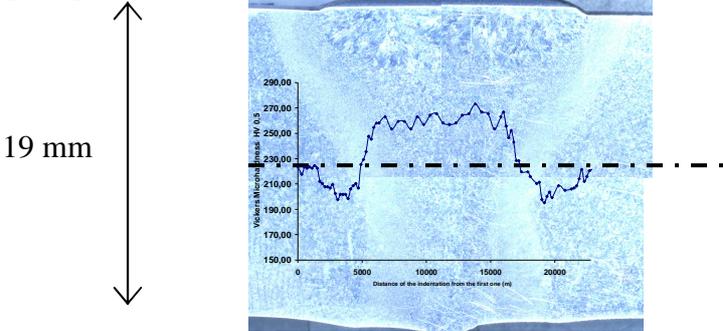
Figure3: Cross-weld microhardness profile combined with observations of the welded joint.

A microhardness profile performed at mid-thickness is symbolized by the dash-dot line in Figure 3. The combination of microhardness profiles and observations of the welded joint allows highlighting the location and the width of the different areas of the HAZ (Figure 4).

The weld metal is the harder part of the joint (the average value is 265 HV). The hardness in the HAZ is varying. A softened zone (200 HV) is observed in the HAZ next to the base metal. It probably corresponds to the ICHAZ. Then, the hardness strongly increases in the HAZ towards the weld metal. The area which is harder than the other zones and located close to the weld metal corresponds to the CGHAZ.

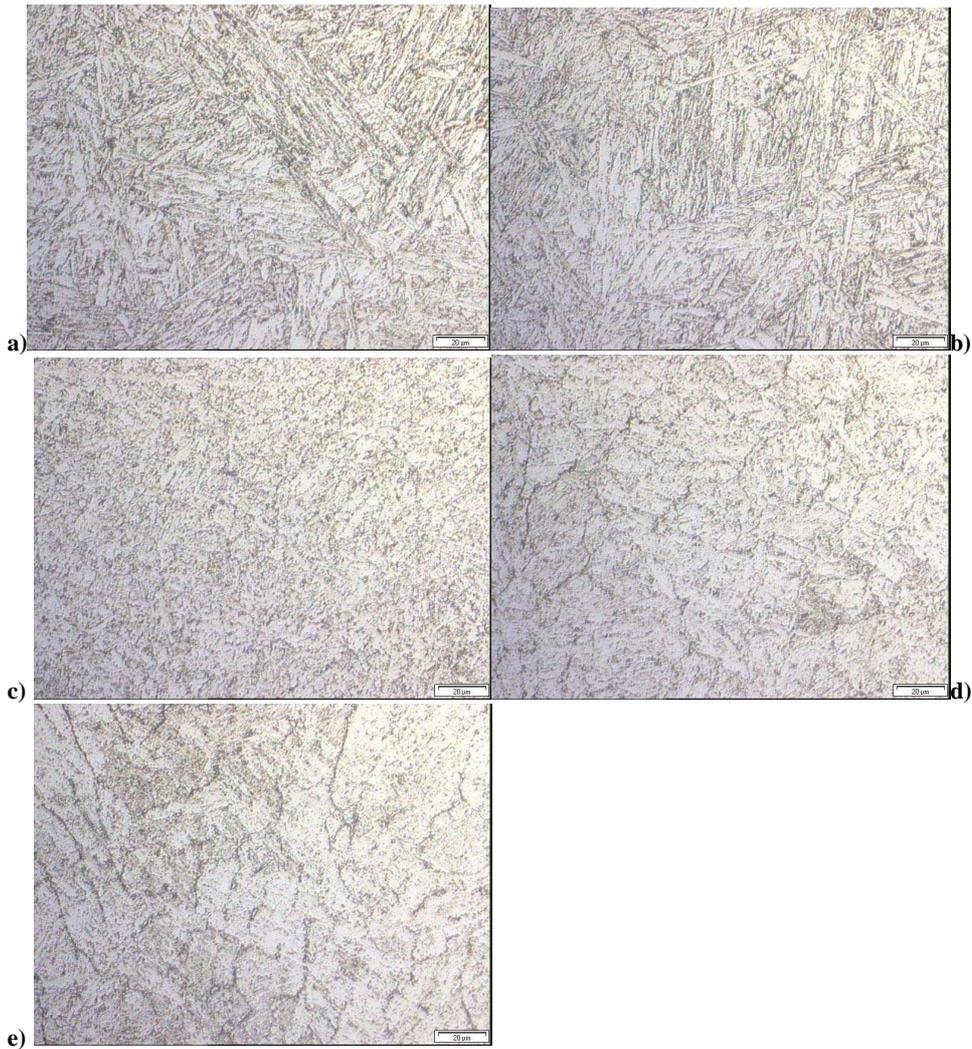
**Figure 4: Optical observations of the different areas of the welded joint: a) the base metal, b) the intercritical area, c) the FGHAZ, d) the CGHAZ and e) the weld metal.**

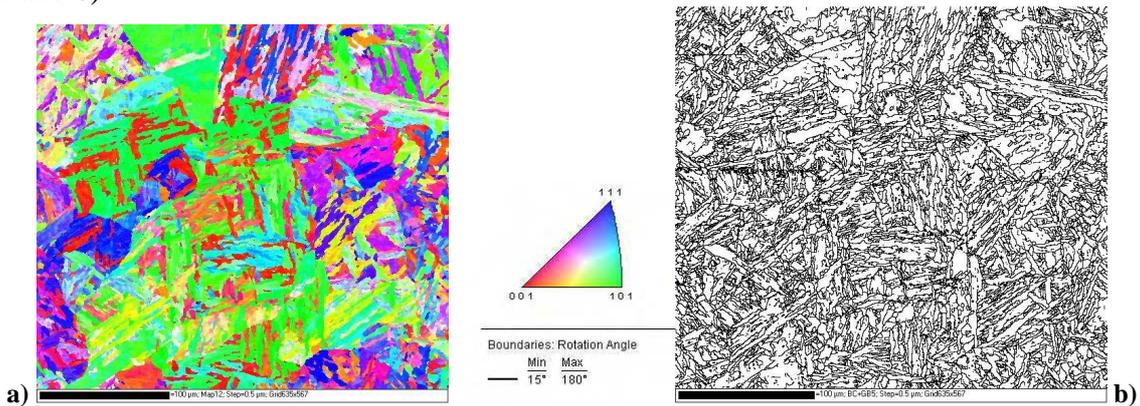
**Figure 5: EBSD orientation map a) and boundary map (misorientation  $>5^\circ$ ) b) of the base metal.**

The microstructure of the base metal is a usual martensitic microstructure made of laths, arranged in blocks and packets (Figures 5 and 6) [4, 5].

The average size of a block is about  $4 \mu\text{m}$  (Detection criterion: misorientation  $> 5^\circ$ ). Giroux [6] estimated the subgrain size of the same base metal to be  $0.37 \mu\text{m}$ . He estimated the average dislocation density of the material at about  $2.10^{14} \text{ m}^{-2}$ .

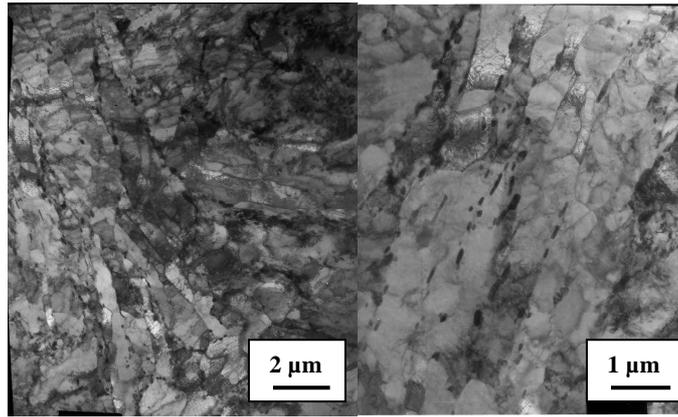
**Figure 6: Bright Field TEM observations of the Base metal.**

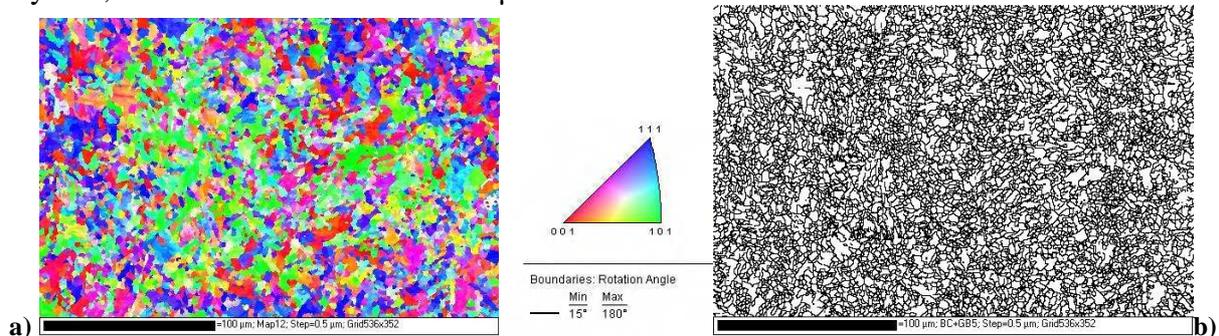
**Figure 7: EBSD orientations map a) and boundary map (misorientation  $>5^\circ$ ) b) of the fine-grained zone.**

The fine-grained zone (FGHAZ) (figure 7) presents a microstructure with very fine crystals, which mean size is about 2.9  $\mu\text{m}$ .

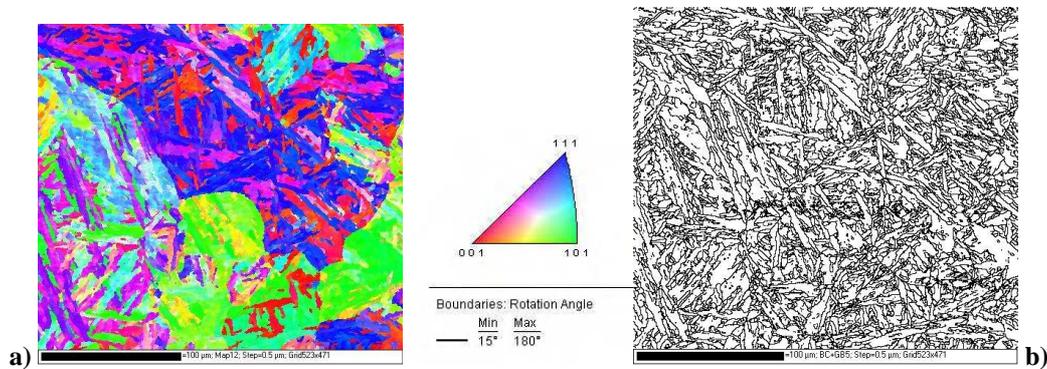
**Figure 8: EBSD orientations map a) and boundary map (misorientation  $>5^\circ$ ) b) of the softened zone.**

EBSD observations of the softened zone show that the microstructure is very similar to that of the base metal at the investigated scale (figure 8). This suggests that the lower hardness might be due to a difference of subgrain or lath size or to a different precipitation state.

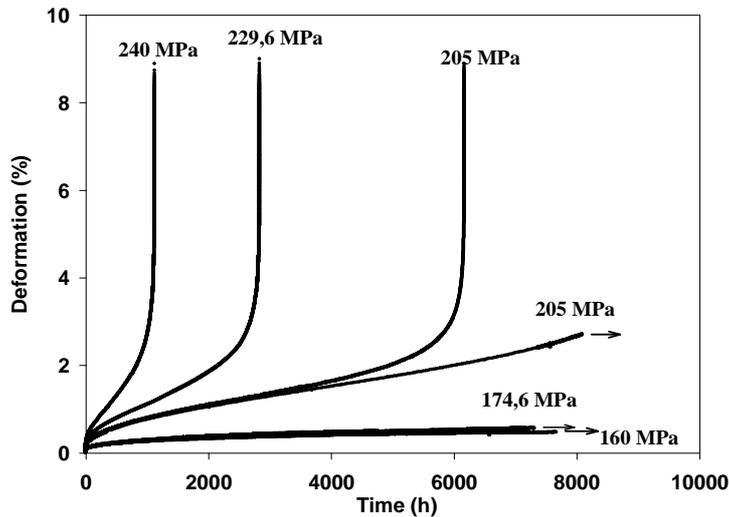
Figure 9: Creep curves at 550°C.

Creep tests results are summarized in Table 2 and Figure 9. Specimens subjected to applied stresses of 229.6 MPa and 240 MPa both broke in the HAZ, very close to the base metal, namely, in the ICHAZ. The specimen crept at 205 MPa has not been observed yet.

The fracture elongation is rather high (several percents). The three typical creep stages are clearly visible in Figure 9. The values of strain at the end of the first two stages are indicated in Table 3. The two creep curves at 205 MPa are superimposed for the first two creep stages but differ in the third stage. However, the ratio between both lifetimes will probably not exceed 2 or 3 as the third stage already started for the ongoing test.

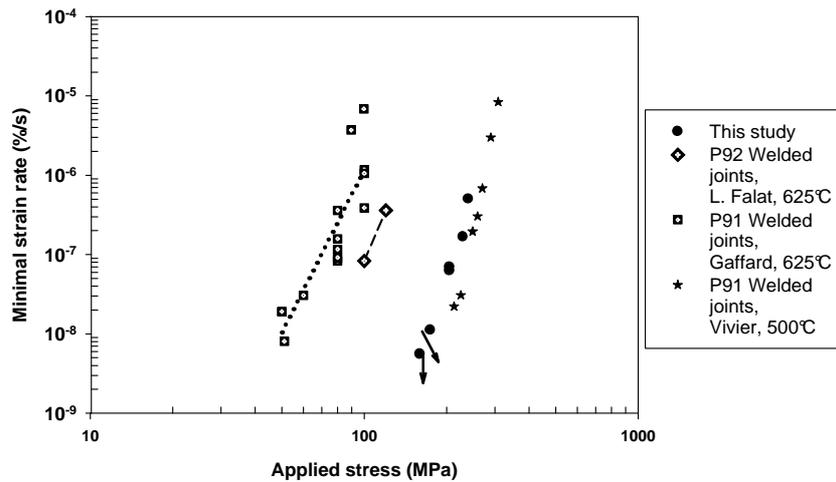
Figure 10: Minimal strain rate versus applied stress for welded joints [3, 6 and 7].

Where  $\dot{\varepsilon}$  is the minimum creep rate,  $\sigma$  the applied stress,  $A$  and  $n$  are parameters depending on material and temperature. For this study, the model gives  $n=11.57$ . This relatively high value suggests that the creep deformation mechanism is controlled by dislocations motion, possibly together with an effect of internal stresses. This result can be compared with the values found at 500°C by Vivier [1] and at 625°C by Gaffard [7] for welded joints of P91 (Figure 10).

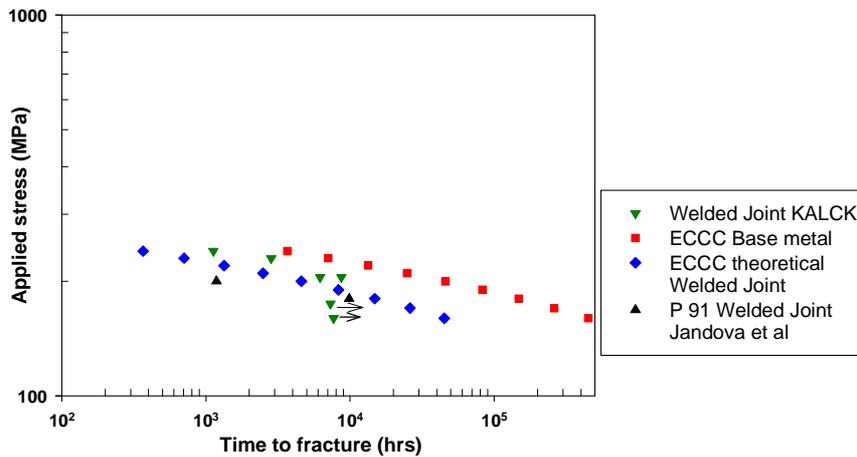
Figure 11: Applied stress versus time to fracture, at 550°C [1, 8].

In Figure 11, ECCC “theoretical” values correspond to times to fracture of welded joint calculated from ECCC base metal values and reduced by a factor of 10 compared to time to fracture of base material [8].

As expected, the creep strength of the welded joint is lower than the creep resistance of the base metal. The ratio between the values of the base metal and the actual welded joint is about 3.3 i.e. three times lower than that expected from “theoretical” ECCC values.

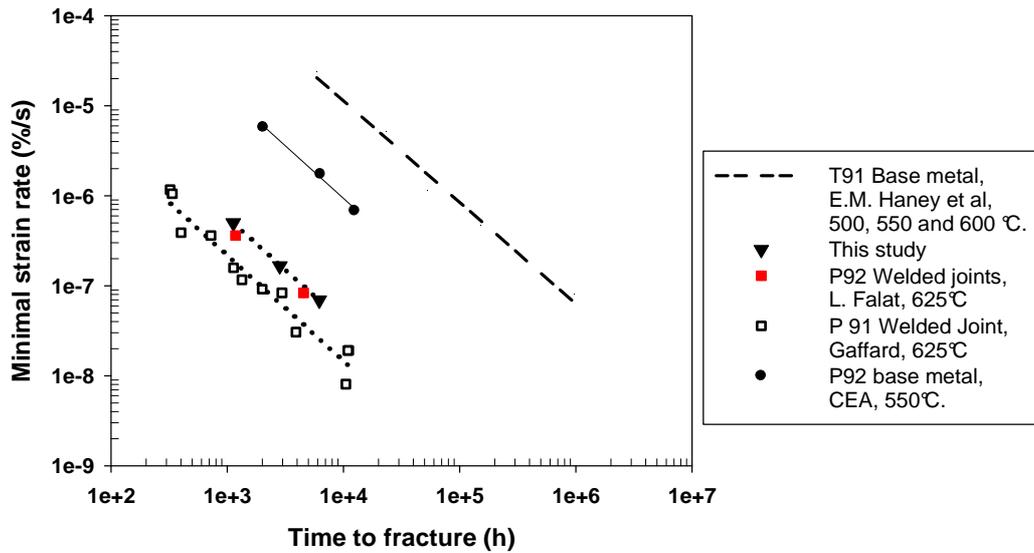
Figure 12: Monkman-Grant curve for crept specimens [8, 9 and 10].

The dashed line in Figure 12 corresponds to a linear approximation of a set of data about T91 at temperatures ranging from 500 to 625°C, studied by E.M. Haney et al [10]. Data about P92 welded joints coming both from this study and from L. Falat experiments [4] are spread homogeneously along the same line.

Besides, we can see that the diminution of P92 properties due to the welding is less significant than for P91. The difference between the Monkman-Grant properties (figure 12) of the welds compared to the base metal is much more pronounced for P91 than P92. This is consistent with the 3.3 ratio observed on the lifetime in figure 11.

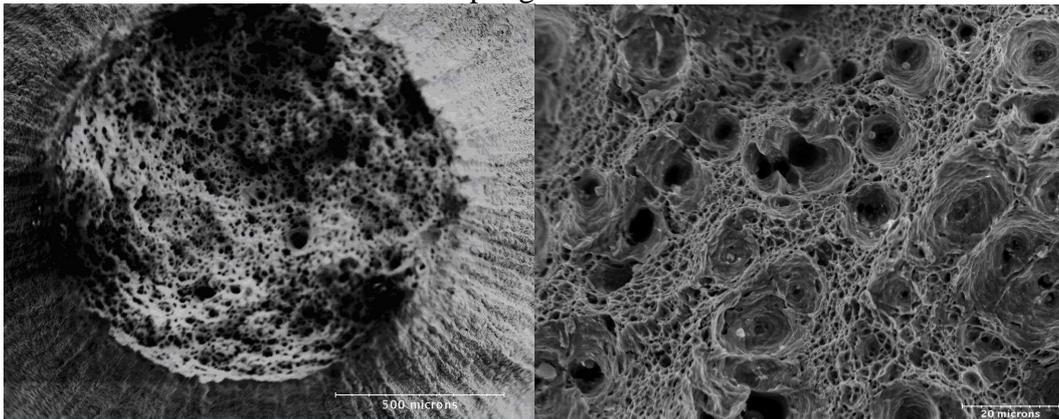
Figure 13: Fracture surface of the crept sample after 2837h (229.6 MPa, 550°C).

Fracture surfaces of broken samples present a circular shape. The fracture mode is transgranular ductile. The fracture surfaces in figure 13 exhibit many dimples, which is typical of a ductile fracture in the dislocation creep regime.

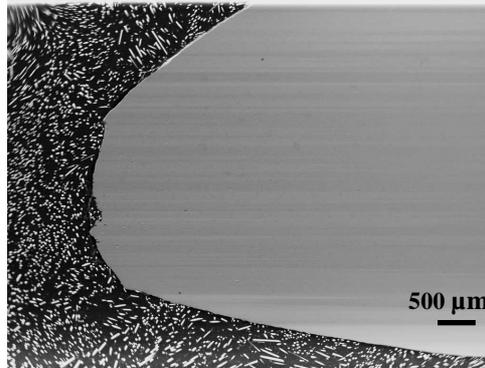
*Figure 14: Necking area of a crept sample (240 MPa, 550°C).*

The samples (figure 14) display a pronounced reduction of area at the fracture surface, which highlights significant plastic deformation before fracture.

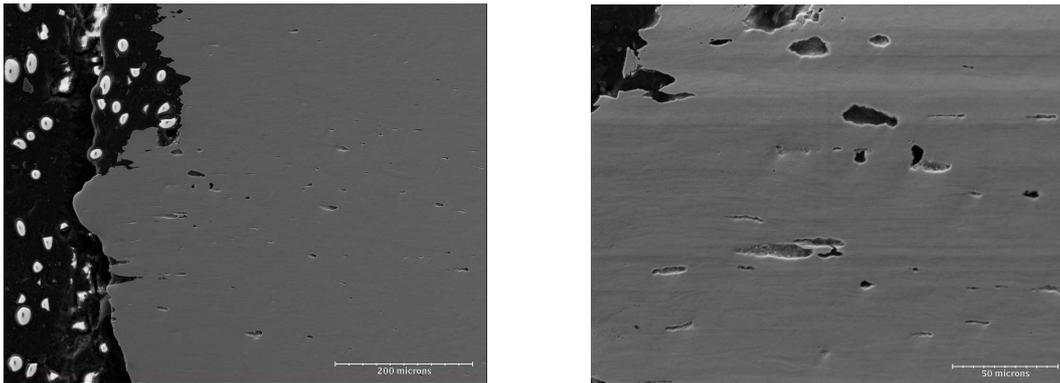
*Figure15: SEM observations of damage in the necking area of crept sample (240 MPa, 550°C, cross-section).*

A lot of cavities and short cracks can be observed in the necking area of the broken specimen (Figure 15). Cavities are elongated along the loading direction.

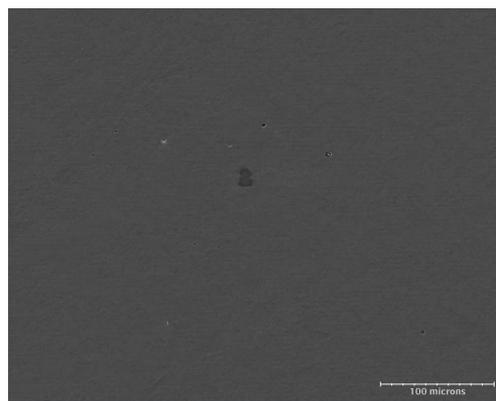
*Figure 16: SEM observations of the cross-section of the crept specimen far from the necking area (240 MPa, 550°C).*

Far from the necking area (figure 16), much lower cavities are concentrated in the necking zone. Therefore, the damage mechanism does not seem to be controlled by vacancy diffusion at 550°C in the tested conditions. This assumption is in agreement with the significant reduction of area and the Norton parameters.

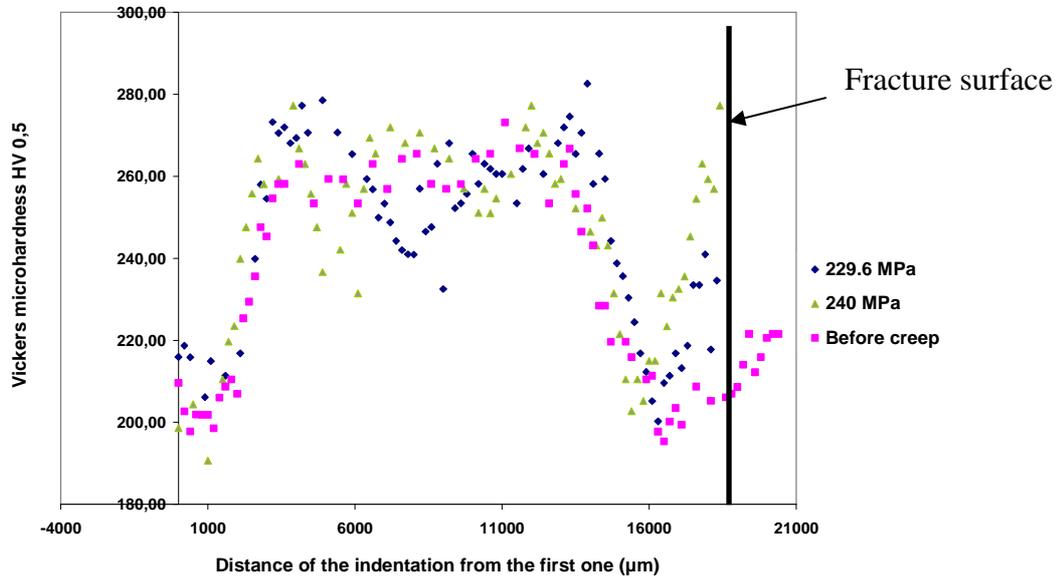
Figure 17: Cross-weld microhardness profiles of two crept specimens

Microhardness profiles were measured on longitudinal cross sections of two creep fractured samples (figure 17), showing a significant increase in hardness in the necking area. This fact is linked to the strain hardening occurring during deformation. Moreover, in the weld metal, hardness values are more scattered than before creep.

The microhardness profiles allowed determining the location of fracture in two specimens. Fracture occurred in the intercritical area for both samples. Table 5 presents the fracture location of samples having experienced creep tests under different conditions.
