# Buckling and Interface Strength Analyses of Thermal Barrier Coatings combining Laser Shock Adhesion Test to Thermal Cycling

## Abstract

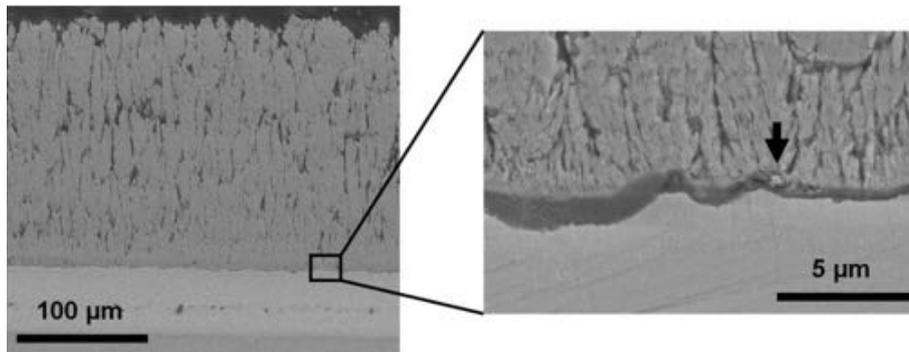
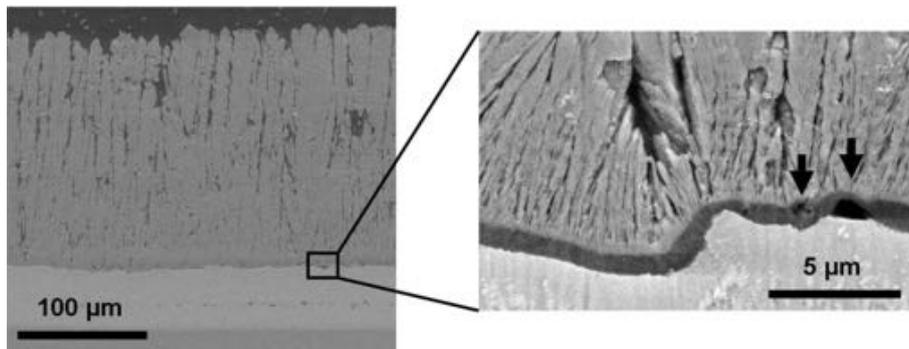
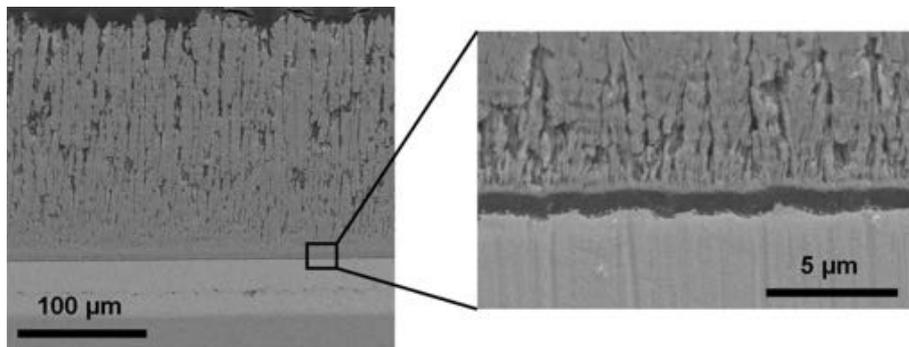
Figure 1: SEM-BSE observation in the as-processed condition for (a) reference, (b) heavy grit-blasting and (c) polishing before BC deposition

Cross-sections in the as-received condition have been observed in back-scattering electrons (BSE) mode to distinguish BC, TGO and TC, Figure 1. For all cases, the interfaces between TC and TGO and between TGO and BC **do not present initial debonding**. Few interfacial defects have been indicated by black arrows on magnified images, but are seldom observed. Besides, the columnar structure of the TC is directly function of local roughness: the higher the local roughness the higher corn-like defects at the bottom of the columns, compare magnified regions of Fig. 1(a) and Fig. 1(b). Oxide thickness ranges from 700 nm to 1  $\mu\text{m}$ , for the three-tested configurations. After 200 cycles, the initial roughness impacts directly the roughness evolution and the interfacial **debonding**, Figure 2. For the reference grit-blasting (GB), few sites of debonding have appeared together with an amplification of both the oxide thickness and roughness of the global TC/BC interface; see black arrows in Fig 2(a). The so-called rumpling effect impacts directly the local roughness with oxide thickening. For heavy GB, this effect is more pronounced and has led to a higher density of debonded sites and larger crack opening, see black arrows in Fig 2(b) and compare magnified regions in Fig 2(a) and Fig 2(b), **the rumpling being higher when associated to initial defect and/or local delamination**. On the other hand, for polished sample, the roughness after thermal cycling is less pronounced that for other samples and no obvious debonding has been observed. Moreover, the slight increase in roughness seems in this case being limited to modification of the only BC/TGO interface, Fig. 2(c). Oxide thickness ranges from 2 to 4  $\mu\text{m}$ , for the three-tested configurations. To determine the impact of surface processing conditions, thermal cycling has been conducted up to ceramic spallation (**20% minimum**), see Table 1. The life to spallation has been increased for both heavy **grit blasted** and polished **surface preparations** as compared to **conventional grit blasting**. Thus, while more interfacial defects have been observed for heavy grit blasting, **a less rough**

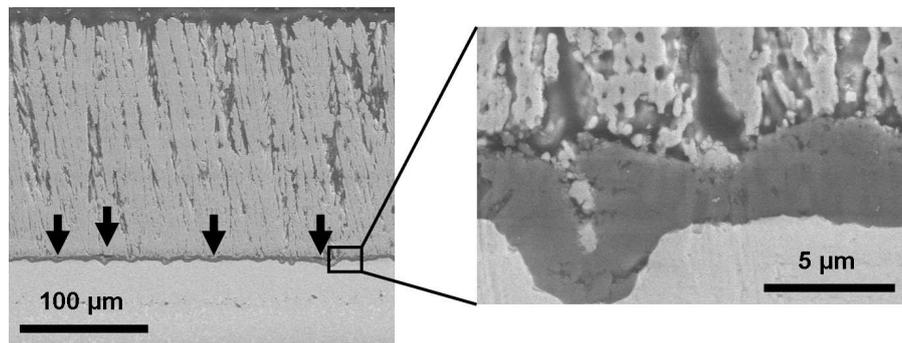
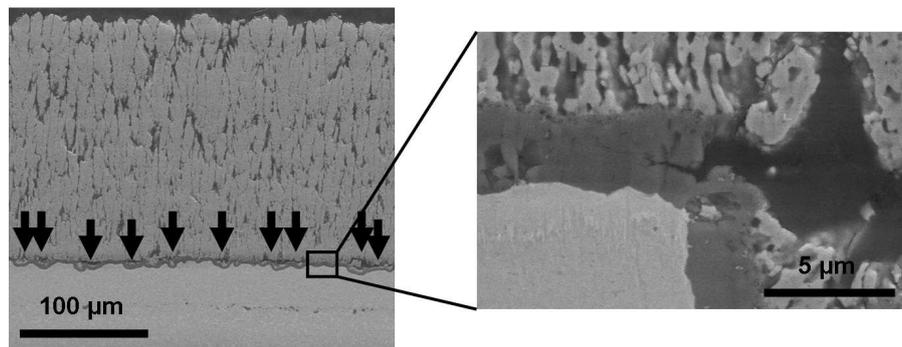
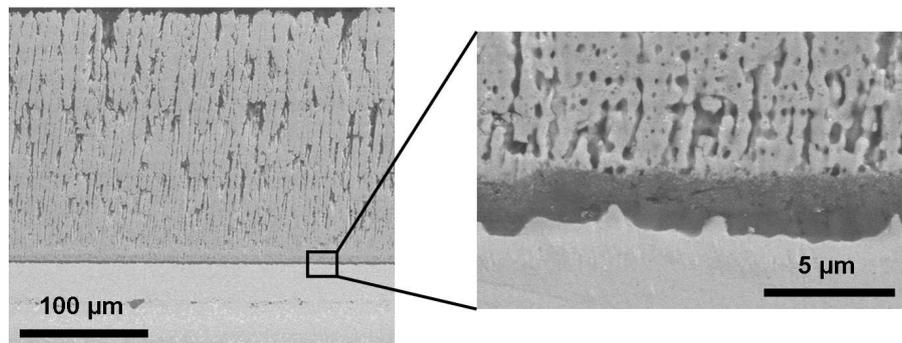
Figure 2: SEM-BSE observation after 200 thermal cycles at 1100 °C/1h for (a) reference, (b) heavy grit-blasting and (c) polishing before BC deposition

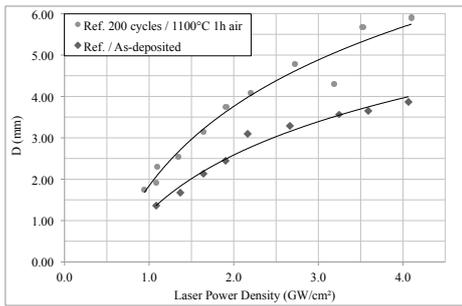
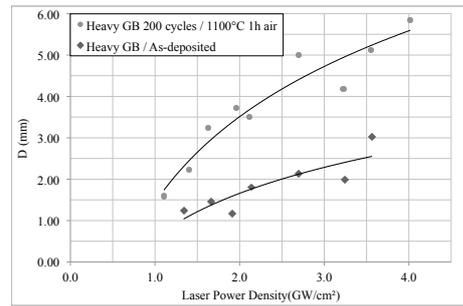
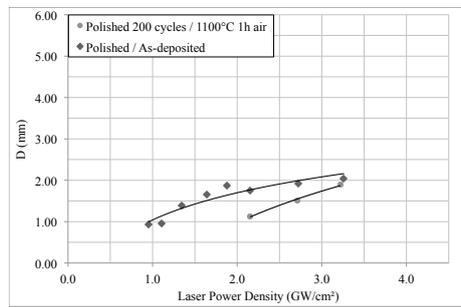
Figure 3: LASAT-2D curves in the as-processed and after 200 thermal cycles at 1100 °C/1h for (a) reference [grit-blasting](#), (b) [heavy](#) grit-blasting and (c) polishing before BC deposition

Using LASAT with increasing laser energy combined to white spot diagnostic, the LASAT-2D curves have been established for the whole set of conditions tested: reference, heavy grit blasting and polished surface in the as-received condition and after 200 thermal cycles, Figure 3. For reference processing condition, the LASAT-2D curve obtained after 200 cycles is above the one obtained for the as-processed condition, Fig 3(a). That is to say that for any laser energy, the diameter of the debonded area is higher after aging than for the same LASAT condition tested for as-processed sample. The LASAT-2D curve after 200 cycles exhibits some large variations in debonded area for laser flux above 3 GW/cm<sup>2</sup>. However, using a log function to fit the experimental results (see continuous lines in Fig. 3) enables to observe a clear ranking for each tested condition. For heavy grit blasting, the same effect is observed: thermal cycling decreases the adherence of the TC, Fig 3(b), but with a lower variation in debonded areas for the whole set of laser flux. As a side note, the as-received condition seems to be more adhesive for high grit blasting as compared to the reference case. However, after 200 cycles, the LASAT-2D curves are very similar for these two conditions. On the other hand the polished samples exhibit a much lower debonding, leading to lower debonding after 200 cycles than observed for the as-processed condition, Fig. 3(c). As a major result, it appears that the final life to spallation is fully consistent with these observations: the polished samples exhibit both the longest life to spallation and the lowest 2D-LASAT curve after 200 cycles. Such demonstration of consistency was obtained using a few number of specimens. Nevertheless, it opens for further thorough study in order to better establish the actual influence of the process condition on the life of coated component using LASAT as a guiding tool to improve the strength of interfaces.

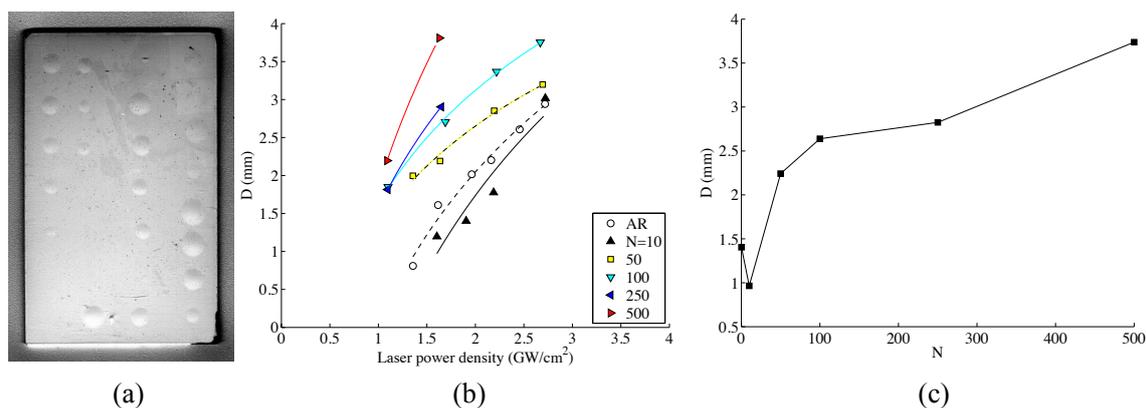
Figure 4: LASAT applied to reference process condition on a rectangular sample (a) surface observation after 500 cycles and (b) LASAT-2D curves for as-processed to 500 thermal cycles at  $1100 \text{ }^\circ\text{C}/1\text{h}$  (c) evolution of debonded diameter as a function of the number of thermal cycles for a laser power density of  $1.6 \text{ GW/cm}^2$ .

In the as-processed condition, the obtained LASAT-2D curve exhibits the smallest debonded area for a 1.4 GW/cm<sup>2</sup> shock, Fig. 4(b). After 10 cycles, the observed debonded area diameters are smaller than in the as-processed condition for the same applied laser power density, appearing as a reinforcement of the

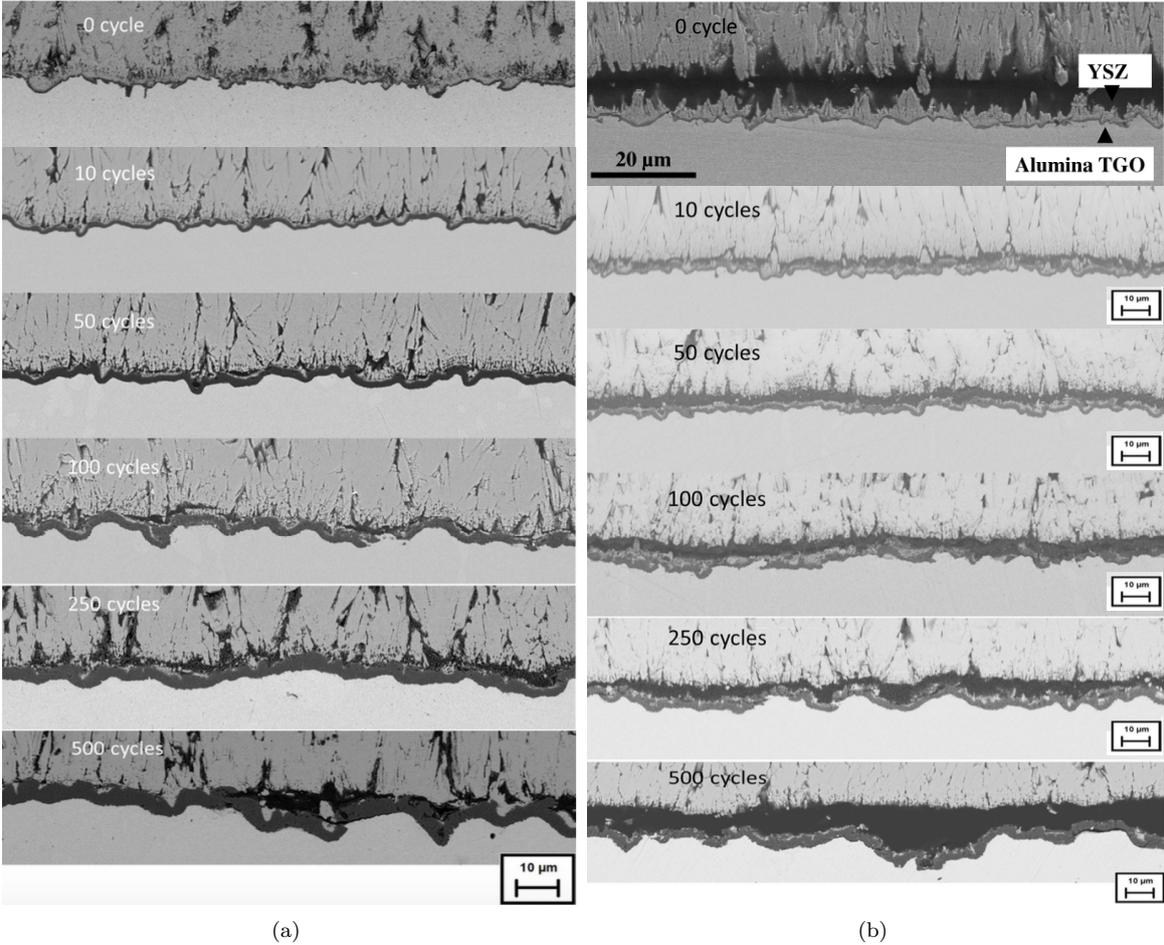
Figure 5: SEM-BSE observation of cross-section for as-processed to 500 thermal cycles at 1100 °C/1h (a) away from the laser shock location (b) through the blister induced by laser shock

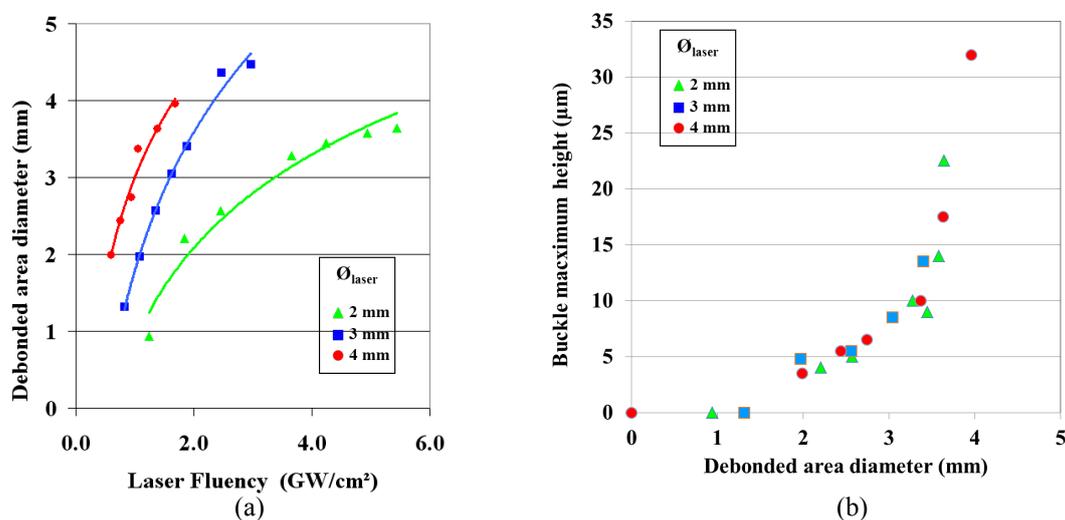
Figure 6: LASAT applied to reference process condition on a rectangular sample (a) LASAT-2D curves for 2mm (green triangle), 3mm (blue square) and 4mm (red dot) of laser shock diameter and (b) evolution of blister height with the size of debonded area (same marker code)

Another series of LASAT-2D curves have been established on a rectangular sample of  $(50 \times 30 \times 2) \text{ mm}^3$  obtained in the reference processing condition. In this experiment, the LASAT was achieved using 2, 3 or 4 mm for the laser shock diameter after 200 thermal cycles. The results are summarized in Fig. 6(a). It

showed that a change in laser diameter modified the LASAT threshold and also the relative position of the LASAT-2D curve. The higher is the laser shock diameter, the higher is the position of the LASAT-2D curve and the lower is the debonding threshold. These results are fully consistent with calculations of the shockwave propagation that led to different spatial distribution and levels of stress when changing the laser diameter for a sample having the same failure threshold [26]. Using profilometry, the whole surface profile of the different blisters can be obtained yielding the maximum blister height for any tested conditions in function of its diameter measured with the white spot analysis, Fig. 6(b). This observation results in a blister that appeared for a debonded area diameter between 1.6 and 2 mm. For higher debonded area diameters, the blister amplitude was obviously increased (without external damaging) to reach  $30 \mu\text{m}$  in height for a debonded diameter of about 4 mm. According to this LASAT experiment, it is worth to note that the various shockwave distribution induced by various laser shock diameter did not affect the resulting buckling behaviour of the TBC sample. Therefore, it is claimed that the buckling phenomenon is not affected by the laser shock condition but generated by the sudden crack induced at the interface and further driven by the release of the (compressive) residual stress initially present in the TC and induced by the processing conditions.

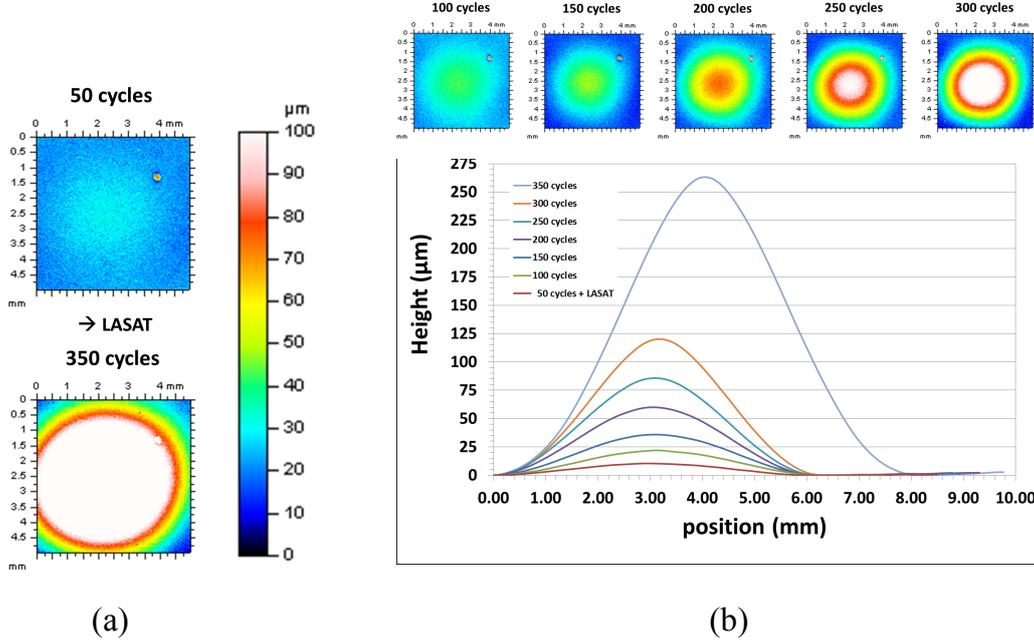
Figure 7: Evolution of blister profile with thermal cycling, initial debonding has been introduced by LASAT after 50 cycles (a) Detail of 3D profilometer measurement at 50 cycles and after 350 cycles (b) Evolution with number of cycles of one profile; inserts amplitude corresponds to (a)

Further thermal cycling has led to a two steps evolution of the chosen blister as compared to its initial configuration. Firstly, the radius of the debonded area,  $R$ , was evolving slightly meanwhile the height of the blister,  $\delta$ , was increasing drastically with the number of cycles for  $N \leq 300$ , Figure 7 and 8. Secondly, a jump in the size of the debonded area was observed for  $N > 300$ . The first step could be assumed to correspond to a constant location of the crack tip, for  $100 \leq N \leq 300$ . For  $N > 300$ , interfacial crack has grown. These observations yield two main points. It is obvious that the debonding obtained by laser shock is associated to local stress relaxation. However, after debonding, the continuous blistering of the ceramic layer shows that thermal cycling is still inducing a certain amount of mechanical loading. If one assumes that after a given number of cycles (here around 300) interfacial debonding occurs, it does mean that the critical interfacial toughness has been reached at this point. The mechanism of blistering does not need to be identified to validate the above assumptions.

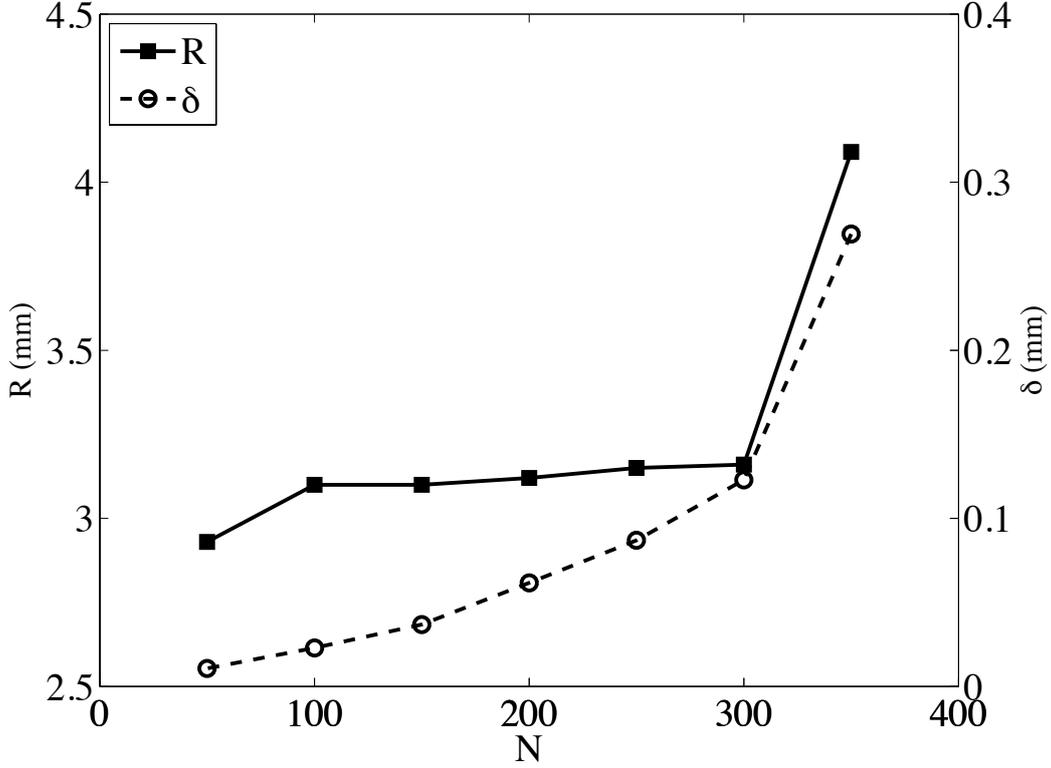
Figure 8: Geometrical evolution of one blister under thermal cycling; an initial delamination has been introduced after 50 cycles, the measurements are the radius  $R$  of the blister and its height  $\delta$

From such important demonstration, it is proposed to combine both LASAT experiments and buckling analysis with interrupted thermal cycles on an other sample submitted to the same experimental procedure shown in Fig. 4. In this case, the complete spallation occurred at 400 cycles and a series of laser shock was achieved after every 50 cycles. As previously established for a similar plate sample, the adhesion level measured by LASAT was decreasing with the number of cycles. From this experiment, one buckle profile was thoroughly analyzed after a laser shock achieved at 50 cycles. The profile of this buckled area was then analyzed every 50 cycles. The evolution of the buckle profile from 50 to 350 cycles (before final spallation at 400 cycles) is shown in Figure 7. Firstly, no macroscopic failure of the ceramic has been observed after 350 cycles. The maximum amplitude of the buckle was  $265 \mu\text{m}$  for a radius of about 4.1 mm. Secondly, from 50 to 300 cycles, almost no drastic growth of the interfacial decohesion has been observed, whilst the blister has increased progressively from 10 to  $125 \mu\text{m}$  approximatively. Moreover, the top-view observations of the 3D-profil show a quasi-perfect circularity of the blister, see insert in Figure 7. Consequently, the assessment of the delamination induced by thermal cycling on a pre-cracked blister can be evaluated consistently through the measurements of the diameter of the debonded area together with the blister height, Figure 8.

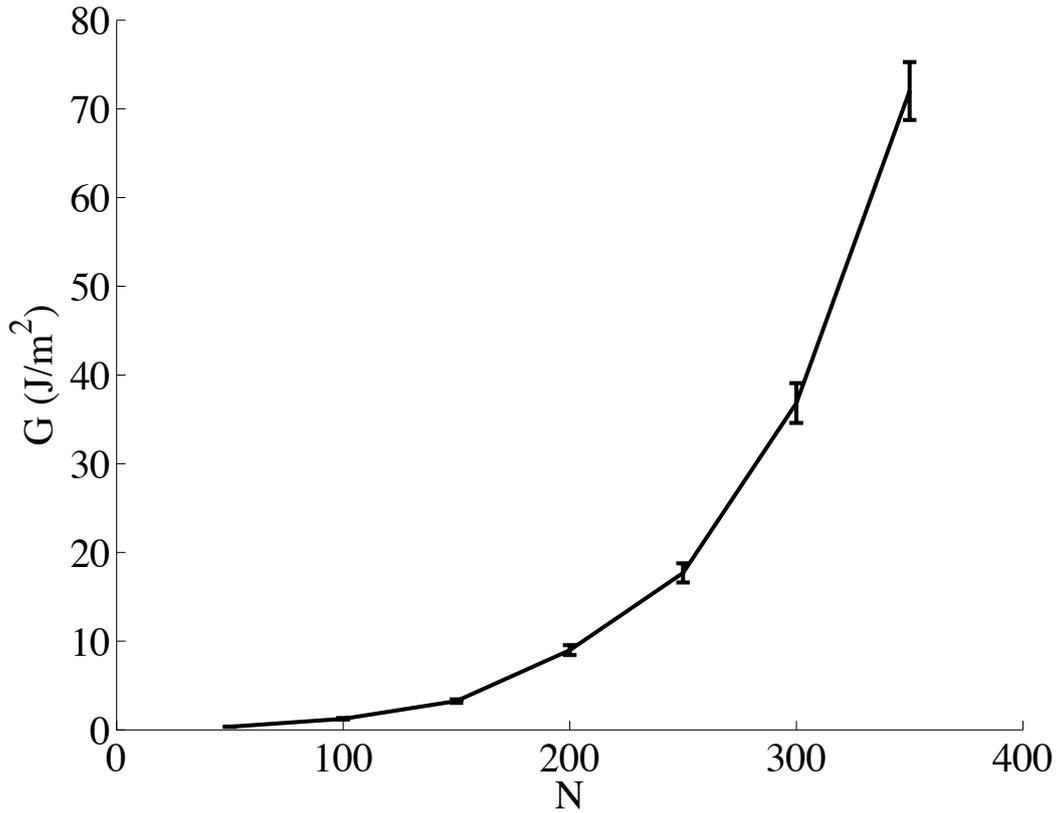
Figure 9: Evolution of energy release rate  $G$  as a function of the number of thermal cycles  $N$  assuming a blister perfectly clamped on its edge

Under the assumptions of buckled-driven delamination,  $G_0$  corresponds to the stored energy in the system within an equibiaxial residual stress level  $\sigma_0$ . The evolution of energy release rate  $G$  could be derived from the global geometrical evolution of the blister and has been plotted as a function of N from experimental measurement obtained for  $E=50$  GPa,  $\nu=0.1$  and  $h_1=180$   $\mu\text{m}$ , Figure 9. This result is fully consistent with an increase of  $G$  without delamination and finally leading to delamination for  $G = G_c$ . At delamination, in our case for  $N=300$  cycles,  $G$  tends to  $36$   $\text{J/m}^2$ . The systematic error induced by radius measurement is about  $\pm 50$   $\mu\text{m}$ . This error induces a maximum of  $\pm 7\%$  on  $G$  evaluation, and has been added to the Figure 9 using error bar. It is worth noting that  $G$  is continuously increasing with N, even after increase in delamination. This raises questions of the validity of chosen assumptions, mainly the perfect clamped boundary condition.

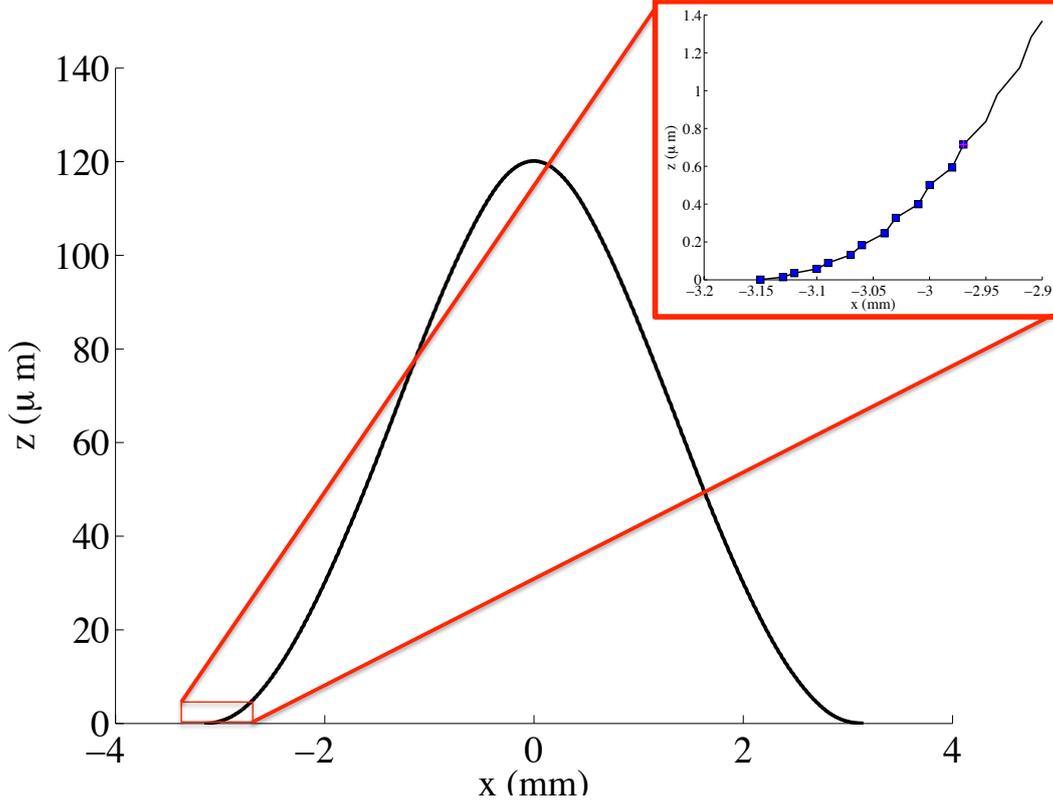
Figure 10: Out-of-plane positions obtained from 3D measurement of the blister for N=300 cycles from Figure 7; insert is magnification of the curve where  $\delta_y^i$  is measured see text for details

A simple assumption consists in associating crack tip opening to the out-of-plane position measurements of the coating surface,  $\delta_y^i$ . That is to say that one assumes to neglect the deformation of the coating itself along its thickness, after laser shock and thermal cycling. Moreover, because there is no measurement of the in-plane displacement, one also neglects the associated terms. Thus pseudo-SIF can be evaluated as proposed for instance by Nagashima et al. (see [33] for complete equations), set of equations 6 to 8:

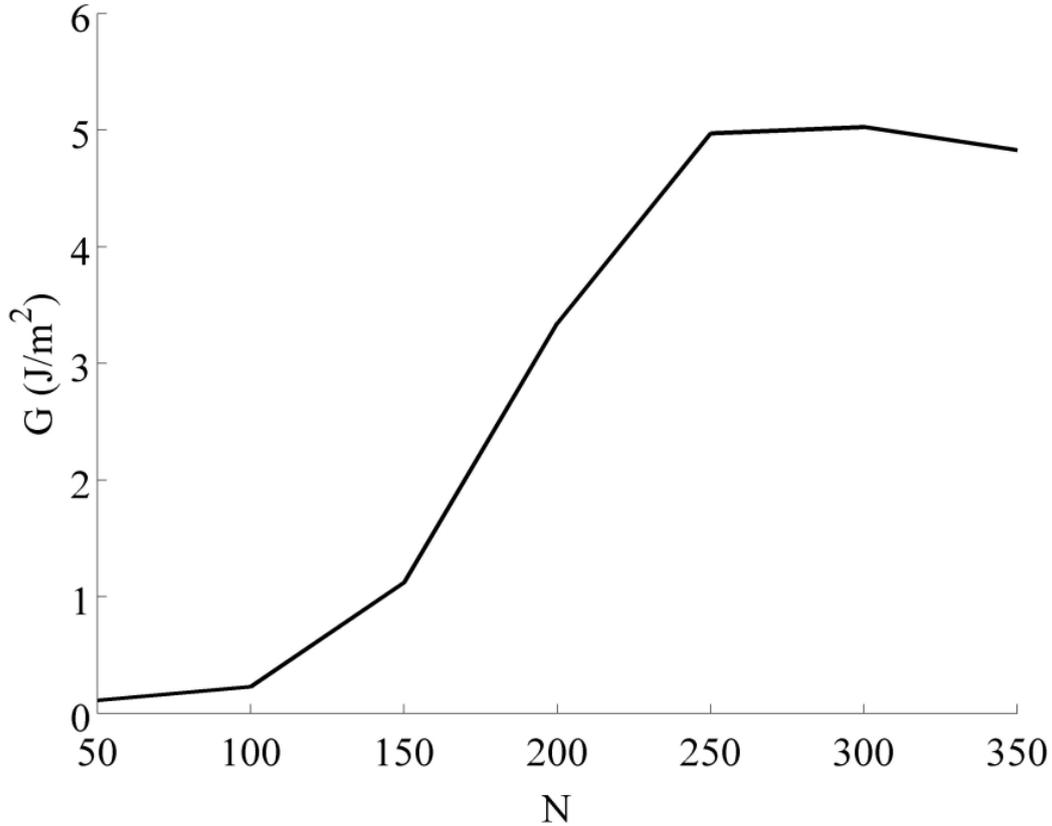
Figure 11: Evolution of energy release rate  $G$  as a function of the number of thermal cycles  $N$  ;  $G$  is derived from pseudo SIF values associated to local measurement of blistering in the vicinity of the crack tip

This method has enabled to obtain again a clear increase of  $G$  up to delamination, then a decrease of

$G$  after delamination was reached. It is worth noting that this method yields much more lower value of  $G_c$  as compared to  $G$  derived from perfectly clamped blister assumption. This point will be discussed in the sequel. At last but not least, the chosen location of the crack tip is the minimum possible value for  $r_a$ . Thus, if delaminated area is higher than assumed, the derived  $G$  values would be lower than the one found with chosen  $r_a$  value. Thus, the proposed evolution of  $G$  finally consists in an upper bound evaluation of  $G$  with the chosen method.

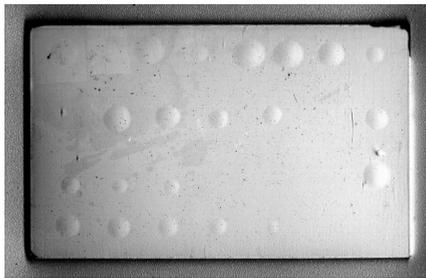
## BLISTERING

Series of laser shocks at different number of cycles

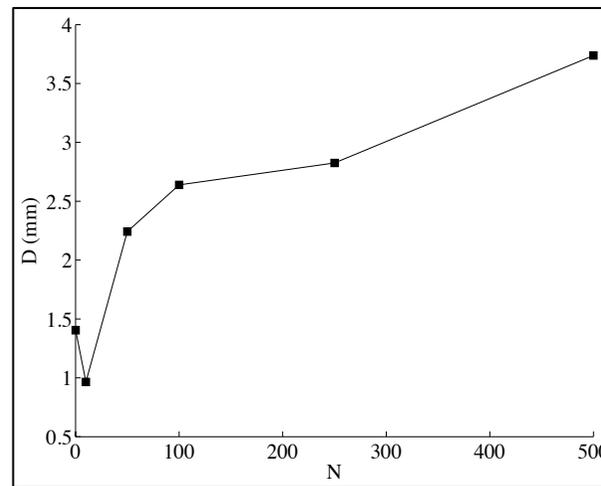
## DELAMINATION

Same laser shock at different number of cycles

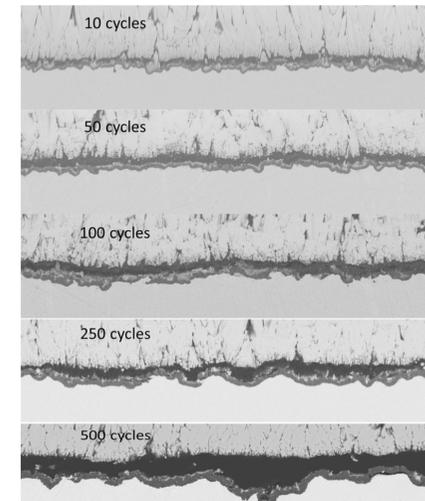
## INTERFACE

Interfacial damage at different number of cycles

- Crack diameter evolution is consistent with a significant decrease of the interfacial toughness with thermal cycling
- After 10 cycles, the weakest interface revealed both by LASAT and thermal cycling is the TGO/TC interface
